WANSON BH/INC 1200

Customer: PTRHTF40127

Dalco Foods B.V Everdenberg 50

Lab No: 02501988 Analyst: Kevin Marson Sample Date: 07/20/22 Received Date: 07/26/22 Completed: 08/03/22

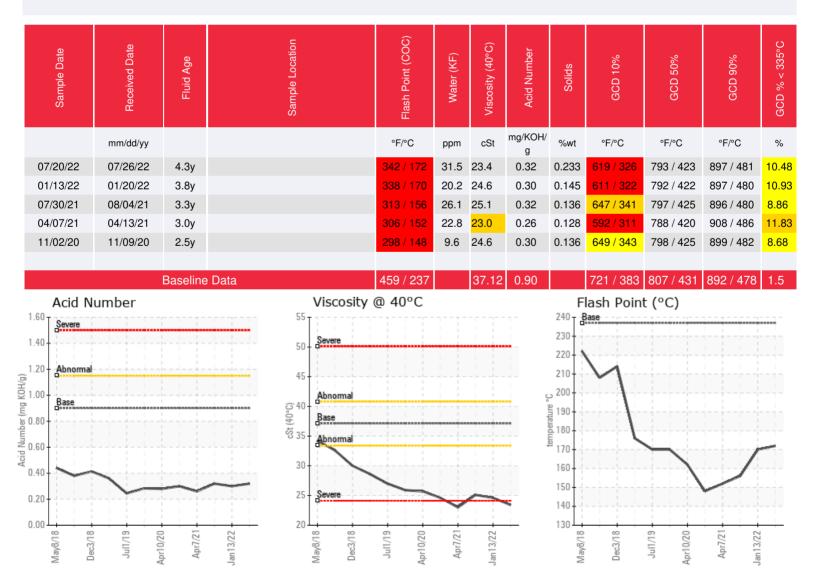
Comments: COC Flash Point is severely low. (GCD) 10% Distillation Point is abnormally low. (GCD) % < 335°C is marginally high.

Recommendation: Flash Point (COC) is very low and off specification. Recommend venting the system in order to reduce number of low boilers and recover flash point. Recommend resampling in six months to monitor.
