TFS H/O SYSTEM #2

Customer: PTRHTF10176	System Information	Sample Information
CERTAINTEED ROOFING	System Volume: 4244 gal	Lab No: 02501991
100 CERTAINTEED DR	Bulk Operating Temp: 525F / 274C	Analyst: Neil Buchanan
JONESBURG, MO 63351 US	Heating Source:	Sample Date: 07/15/22
Attn: Jeff Montgomery	Blanket:	Received Date: 07/26/22
Tel: (952)261-9532	Fluid: PETRO CANADA CALFLO AF	Completed: 07/27/22
E-Mail: jeffrey.d.montgomery@saint-	Make: FSE	Neil Buchanan
gobain.com		neil.buchanan@HFSinclair.com

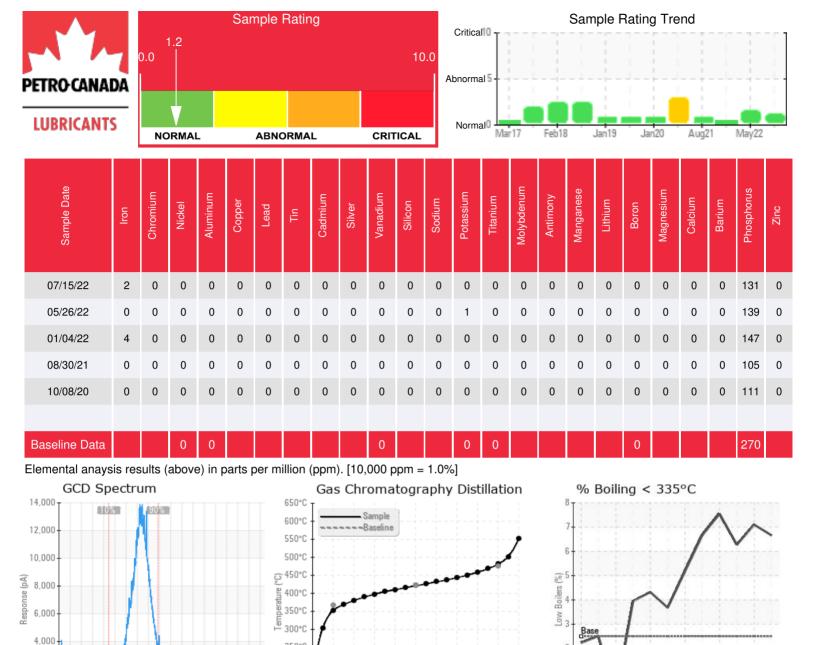
Percent Recovered

Recommendation: Flash Point is very low and GCD % <335C is elevated showing the formation of low boilers.

Comments: COC Flash Point is abnormally low. Visc @ 40°C is abnormally low.
