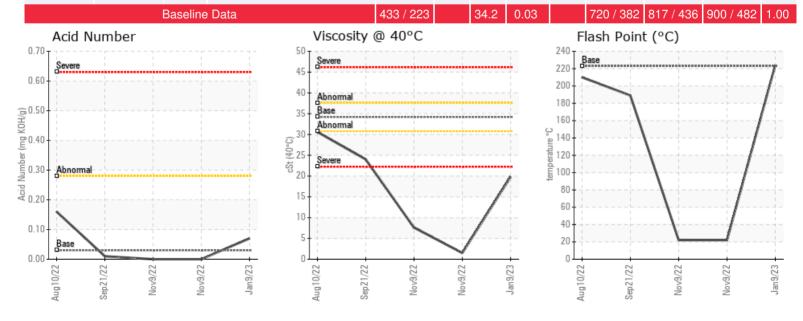
Recommendation: This is the first sample taken after the previous fill was drained, flushed with diesel and then re-filled with fresh Petro-Therm.Sample results indicate that the fluid is in suitable condition for continued service. However, fluid viscosity is still well below fresh Petro-Therm and low boiling vapor content is quite high at 13%, possibly related to residual flushing medium. System needs to be vented to reduce the amount of low boiling vapors.Please re-sample in 3 months but only after a thorough venting regime.

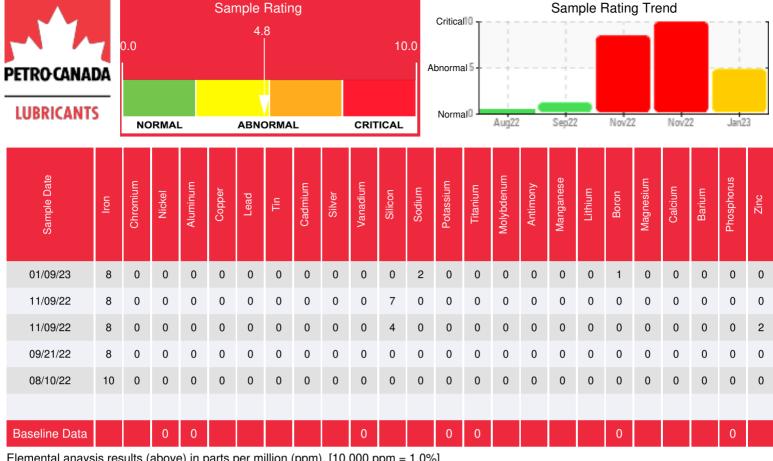
Elemental anaysis results (above) in parts per million (ppm). [10,000 ppm = 1.0%]

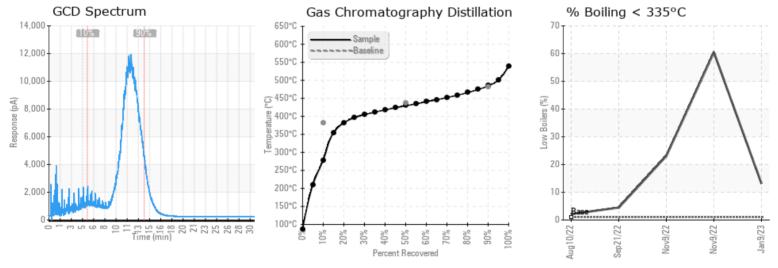
Historical Comments

11/09/22	Sample results indicate extreme contamination with process fluid. Fluid needs to be replaced immediately. Do not run the system as flash point is dangerously low. (GCD) % < 335°C is severely high. (GCD) 10% Distillation Point is severely low. (GCD) 50% Distillation Point is severely low. (GCD) 90% Distillation Point is severely low. COC Flash Point is severely low. Visc @ 40°C is severely low.
11/09/22	Sample results indicate extreme contamination with process fluid. Fluid needs to be replaced immediately. Do not run the system as flash point is dangerously low. We understand there is also evidence of solids in the accumulator and pump inlet screens, indicative of fluid degradation. Please contact Petro-Canada Lubricants tech services to discuss cleaning and flushing (GCD) % < 335°C is severely high. (GCD) 10% Distillation Point is severely low. COC Flash Point is severely low. Visc @ 40°C is severely low.

09/21/22	Sample results indicate symptoms related to either thermal degradation, mixing with process fluids and/or high blanket gas pressure: see reduced fluid viscosity and flash point and increased low boiler vapor content (4.45%). It is advised to perform regular venting of the expansion tank to remove the low boiler vapors which will help improve these parameters. Please contact Petro-Canada Technical Services to discuss further
08/10/22	Sample results indicate the fluid is in suitable condition for continued service. Note fluid viscosity is slightly reduced from new. Please re-sample in 6 months to build a trend. Visc @ 40°C is abnormally low.
