[VIT E 116] EAST

Customer: PTRHTF10004	System Information	Sample Information
ADM VITAMIN E PLANT	System Volume: 2200 gal	Lab No: 02537682
3700 EAST DIVISION STREET	Bulk Operating Temp: 550F / 288C	Analyst: Yvette Trzcinski
DECATUR, IL 62526 USA	Heating Source:	Sample Date: 01/26/23
Attn: Rick Cluck	Blanket:	Received Date: 02/06/23
Tel: (217)451-7770	Fluid: PETRO CANADA PURITY FG HEAT TRANSFER FLUID	Completed: 02/08/23
E-Mail: ricky.cluck@adm.com	Make: AMERICAN HEATING	Yvette Trzcinski
		yvette.trzcinski@HFSinclair.com

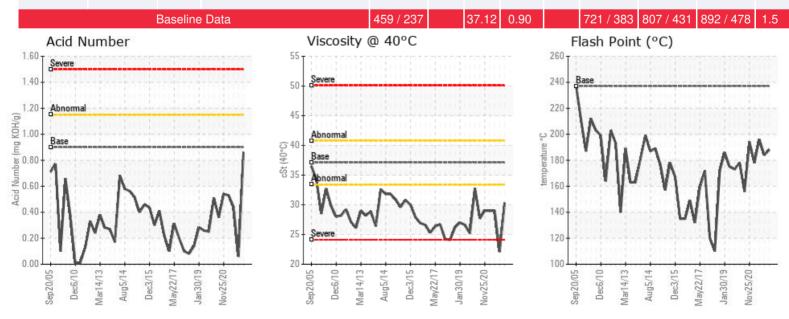
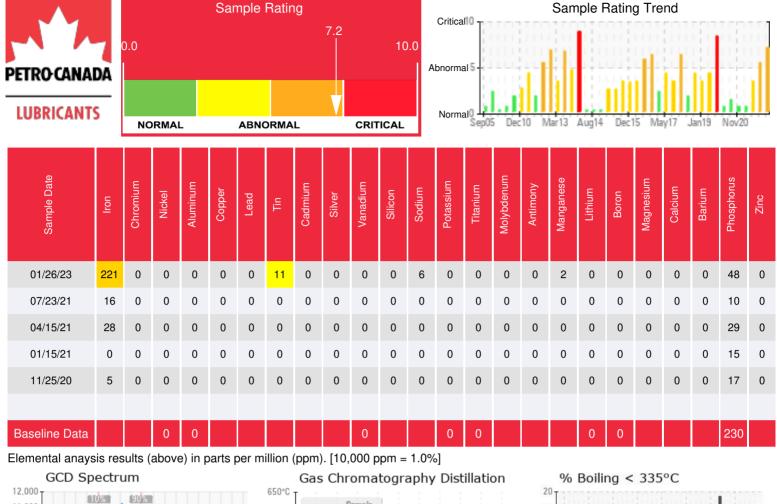
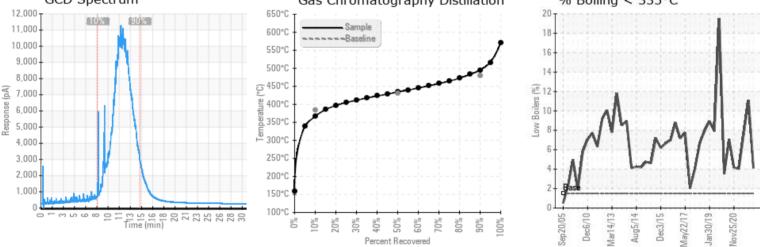
Comments: PQ levels are severe. Iron ppm levels are abnormal. Tin ppm levels are marginal. (GCD) 90% Distillation Point is abnormally high. COC Flash Point is abnormally low.

Recommendation: Sample has a large amount of ferrous material in the sample. Iron wear metals are high inspect the pump. Viscosity and acid number are at acceptable levels. Do see some fluid degradation lowering flash point and GCD Distillation at 90%. if a filtration unit designed for Heat Transfer systems is available recommend filtering the oil. Resample in 3 months.
