## LINE 1

## Customer: PTRHTF10164

Fluid: PETRO CANADA CALFLO HTF

Lab No: 02541173 Analyst: Garrett Bapp Sample Date: 01/03/23 Received Date: 02/23/23 Completed: 03/10/23

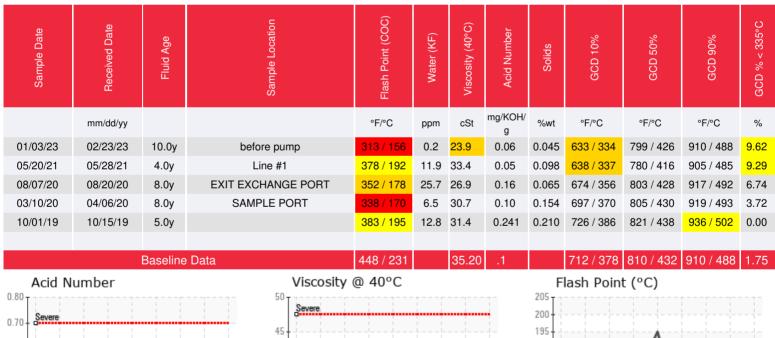
Comments: COC Flash Point is severely low. (GCD) 10% Distillation Point is abnormally low. Visc @ 40°C is abnormally low. (GCD) % < 335°C is marginally high.

Recommendation: Thermal degradation is still present in this system. Viscosity has fallen out of grade. Flash Point is 75°C below base line. GCD 335°C continues to be elevated and GCD 10% is below base line reference. All indications that Low Boilers are present. No indication that carbonaceous deposits are present. Recommendation is the vent the system and replace 50% of the system volume. Since the system is still in good health and 600 gallons, we may want to speak about just doing a full system change out before the system gets to a critical state.

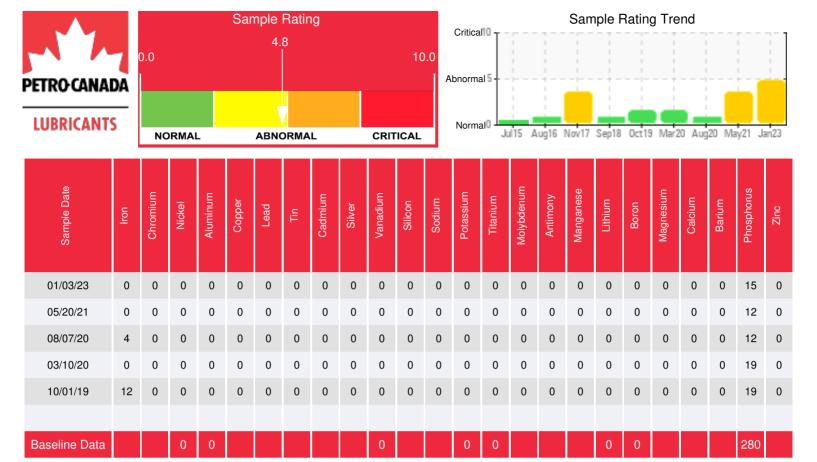
Elemental analysis results (above) in parts per million (ppm). [10,000 ppm = 1.0%]
