LINE 1/2

Customer: PTRHTF60002	System Information	Sample Information
BOYNE SMELTERS LTD-RIO TINTO HANDLEY DRIVE QUEENSLAND BOYNE ISLAND, QUE 4680 AUSTRALIA Attn: Heath Mitchell Tel:	System Volume: 20000 ltr Bulk Operating Temp: 514F / 268C Heating Source: Blanket: Fluid: PETRO CANADA CALFLO AF Make:	Lab No: 02561482 Analyst: Philip Riley Sample Date: 03/13/23 Received Date: 06/02/23 Completed: 06/25/23 Philip Riley philip.riley@HFSinclair.com

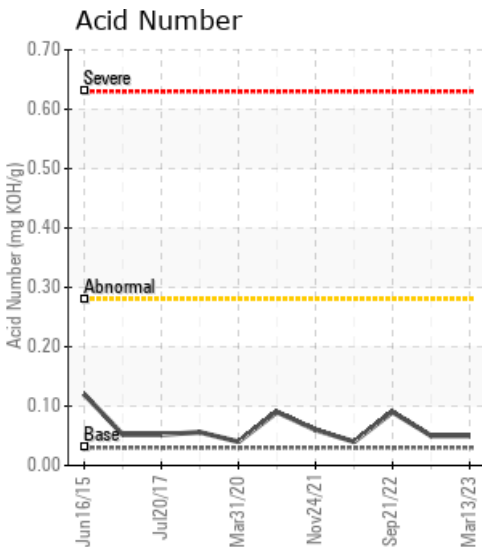
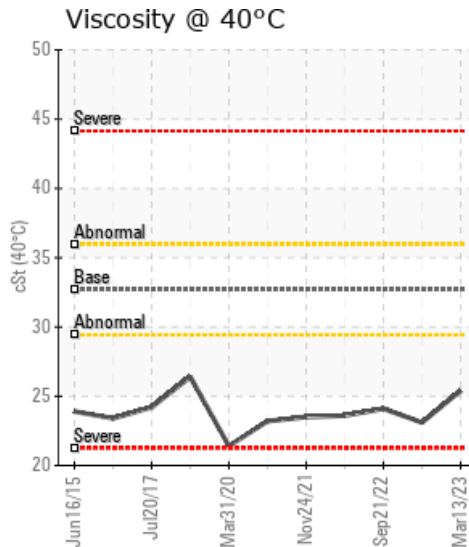
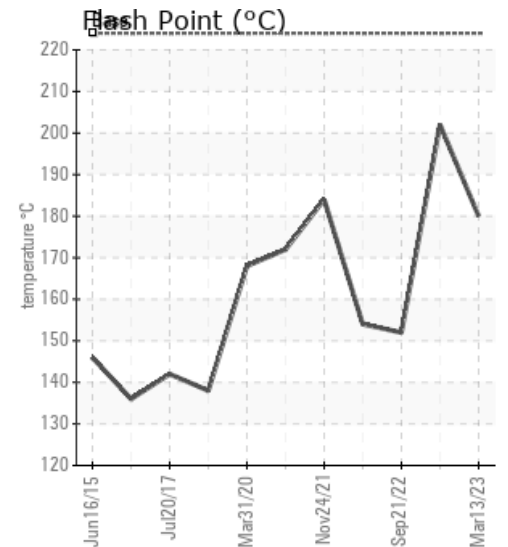
Recommendation: Fluid recovered slightly from partial change (?) previously. Viscosity tracking down, along with flash point which shows continued thermal stress to the fluid. Please resample at normal frequency and as I believe a change is scheduled, there may be degradation at a slightly higher rate as some residual fluid remains following sweetening.

Comments: Visc @ 40°C is abnormally low. COC Flash Point is marginally low.
