[6-10-44-12W5] HEAT TRANSFER

Customer: PTRHTF20171

$\label{eq:continuous_problem} \mbox{Keyera Energy - Nordegg River Gas P...}$

06-10-044-12w5

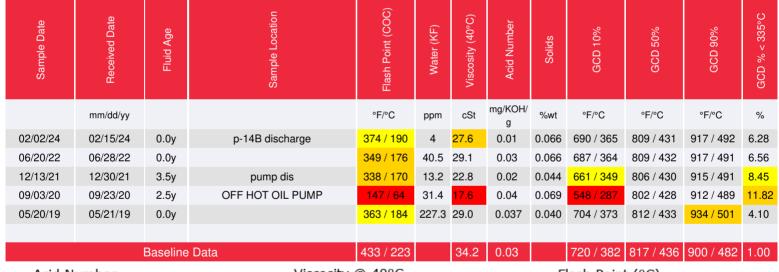
Comments: Visc @ 40°C is abnormally low. COC Flash Point is marginally low.

Recommendation: Viscosity has dropped slightly from last sample but flash point is continuing to improve. If venting is being done to reduce low boilers it has been helping to improve fluid condition. Continue current venting practice to attempt to increase viscosity and COC flash point while continuing to lower GCD %<335C. High blanket pressure can allow fuel gas be entrained in the fluid and cause a reduction in viscosity and flash point. Petro Canada Lubricants recommends blanket gas pressure of 2-3 PSI if pump NPSH is not artificially increased by high blanket gas pressure. Resample in 6 months.

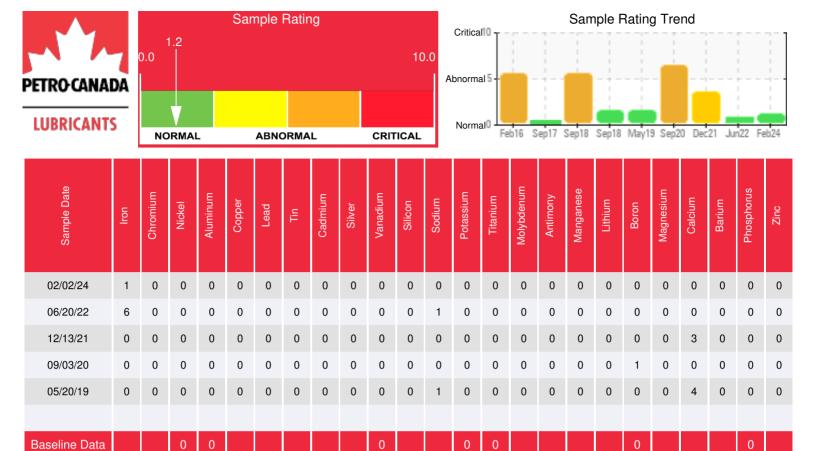
Elemental analysis results (above) in parts per million (ppm). [10,000 ppm = 1.0%]
