## **KAONA FUTHER 5**

# **System Information**

Fluid: PETRO CANADA PURITY FG HEAT TRANSFER FLUID

### Sample Information

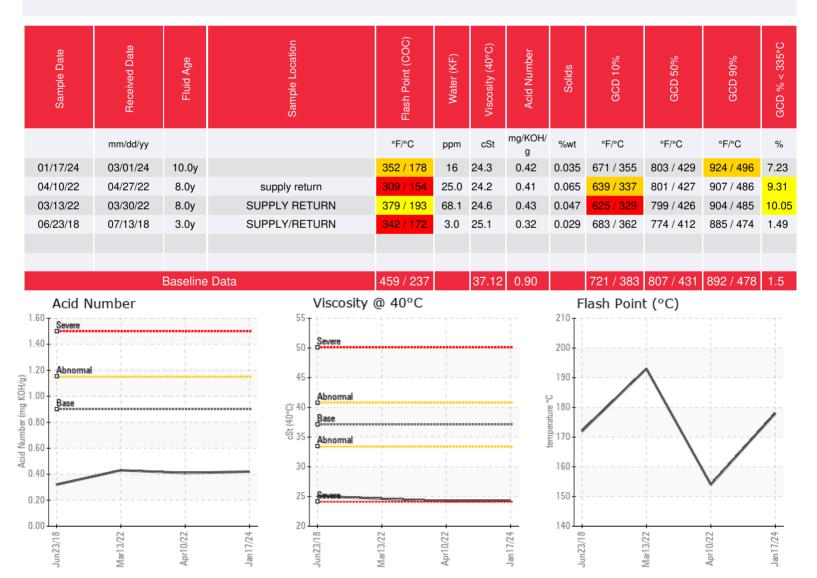
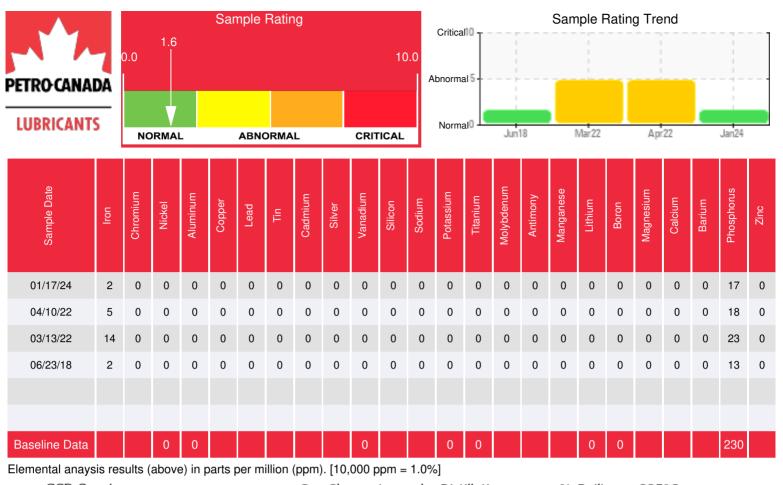
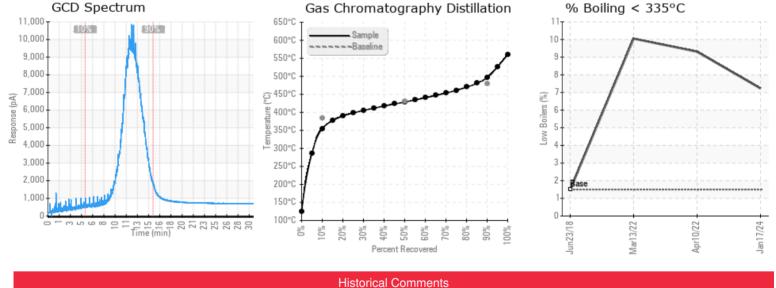
Comments: (GCD) 90% Distillation Point is abnormally high. COC Flash Point is abnormally low.

GCD analysis indicates light ends present in the fluid. Recommend venting the expansion tank to removal any volatiles present in the fluid to restore the flash point of the fluid. Resample at the next service interval to monitor. COC Flash Point is severely low. (GCD) 10% Distillation Point is abnormally low. (GCD) % < 335°C is marginally high. The condition of the fluid is acceptable for the time in service.

Last sample the recommendation was for venting and it can be seen on the GCD curve the spike of low boiling material has gone. However, and as you will see the viscosity remains low, so this action has bought some time, and the fluid will likely deteriorate again. Recommend another sample in 6 months to monitor, with a view as changing oil, including a clean and flush (GCD) 10% Distillation Point is severely low. (GCD) % < 335°C is marginally high. COC Flash Point is marginally low.

The current fluid has normal distillation points, low acid number, low solid contents. However, the low flash point is a concern due to the high bulk oil temperature. Please do the system venting and release the low boiler as soon as possible. Please take one sample in 6 months to monitor the conditions. COC Flash Point is severely low.

Recommendation: We recommend that you continue to vent the expansion tank to remove low boilers which assists in restoring the flash point of the fluid. The fluid is suitable for further service. We recommend an early resample to monitor this condition.
