UNIT A

Customer: PTRHTF30035	System Information	Sample Information
VEOLIA WATER 9 LESLIE STREET TORONTO, ON M4M 3M9 CA Attn: MICHAEL VULJICIC Tel: (416)996-2340 E-Mail: michael.vujcic@veolia.COM	System Volume: 6000 ltr Bulk Operating Temp: 280F / 138C Heating Source: Blanket: Fluid: PETRO CANADA CALFLO HTF Make:	Lab No: 02623559 Analyst: Behshad Sabah Sample Date: 03/15/24 Received Date: 03/20/24 Completed: 03/25/24 Behshad Sabah behshad.sabah@HFSinclair.com

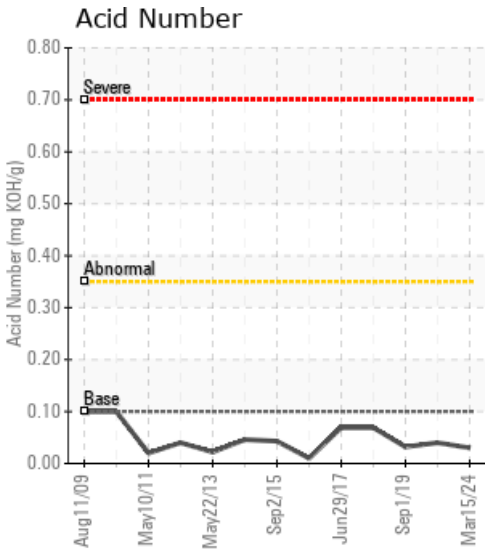
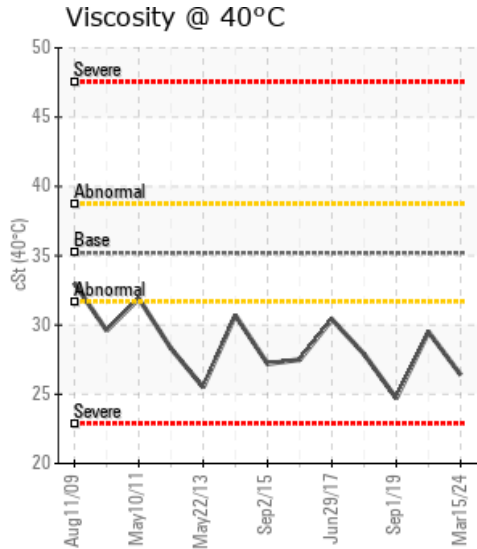
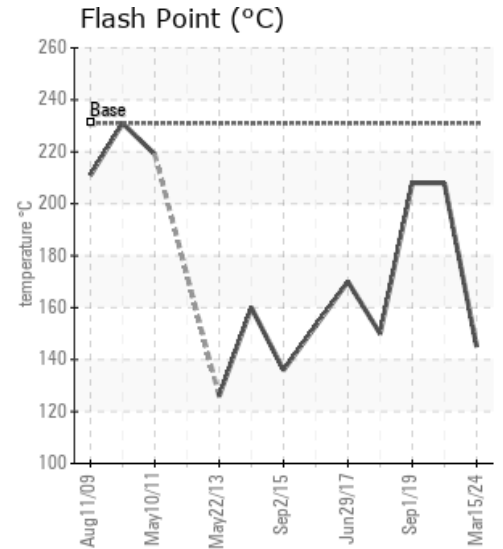
Recommendation: the test results show an abnormal spike on the sulfur ppm of the oil which can be a product contamination by added wrong oil. the wrong oil - may be gear oil- has been cracked and dropped the overall mix viscosity and a significant drop on the flash point. you cannot filter the wrong oil out, but you need to 'sweeten' the system. drain 10% to 20% of the volume and top up with fresh Clafo HTF before it gets too late. the wrong oil oxidation will increase the pentane insoluble percentage to the point that you need to drain, clean, and flush the system. at this moment no chemical corrosion is detected in the system. there is low risk of pinholes and leak.

Comments: COC Flash Point is severely low. Visc @ 40°C is abnormally low. (GCD) % < 335°C is marginally high.
