WANSON BH/INC 1200

Customer: PTRHTF40127	System Information	Sample Information
Dalco Foods B.V	System Volume: 4200 gal	Lab No: 02624515
Everdenberg 50	Bulk Operating Temp: 518F / 270C	Analyst: Bill Quesnel CLS,OMA II,MLA-
Oosterhout, 4902TT NL	Heating Source:	III,LLA-I
Attn: Wilbert Snijers	Blanket:	Sample Date: 03/19/24
Tel:	Fluid: PETRO CANADA PURITY FG HEAT TRANSFER FLUID	Received Date: 03/25/24
E-Mail: w.snijers@klt.nl	Make: WANSON	Completed: 04/08/24
		Bill Quesnel CLS,OMA II,MLA-III,LLA-I

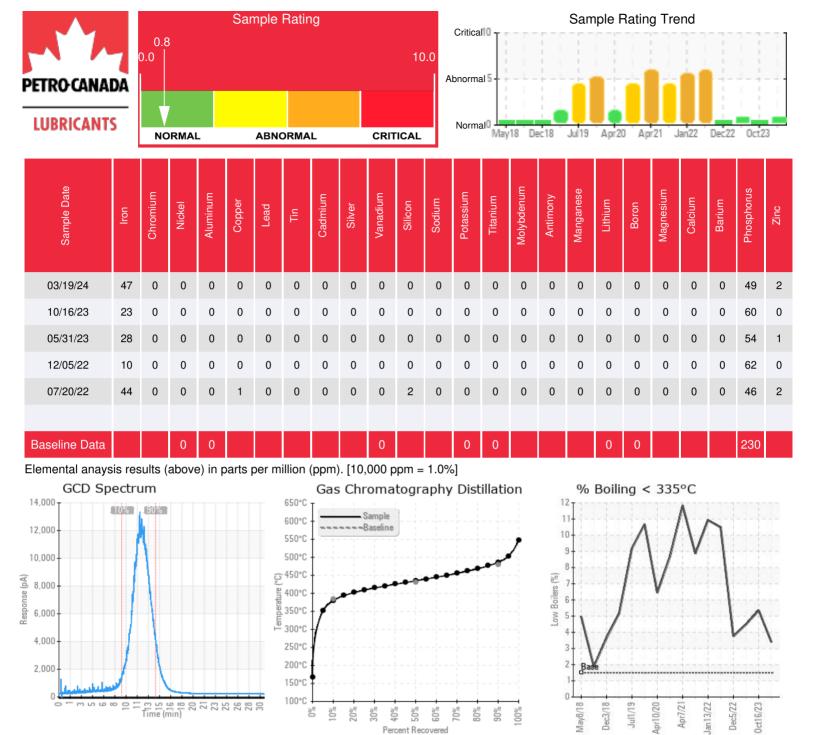
Percent Recovered

Comments: COC Flash Point is marginally low.

Recommendation: We recommend that you vent the expansion tank to remove low boilers which assists in restoring the flash point of the fluid. The fluid is suitable for further service. Resample at the next service interval to monitor.
