2018.03.8865 - Diesel Engine

Sample No: LH0274480

LIEBHERR CANADA LTD. - REMAN

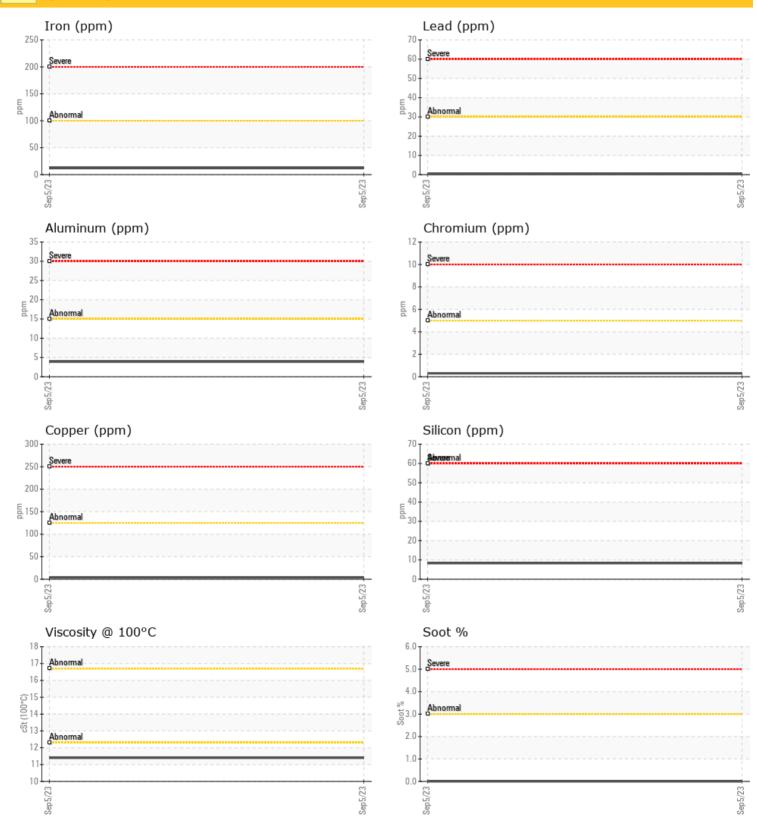
GRAPHS

No corrective action is recommended at this time. Resample at the next service interval to monitor. Please specify the brand, type, and viscosity of the oil on your next sample.All component wear rates are normal. Elevated aluminum (Al) and/or lead (Pb) and potassium (K) levels in your metals analysis are likely a result of solder flux release into the lubricant and is common on new equipment/components. Light fuel dilution occurring. No other contaminants were detected in the oil. Viscosity of sample indicates oil is within SAE 30 range, advise investigate. The condition of the oil is acceptable for the time in service.
