### LIEBHERR L556 055501-1332 - Coolant

Sample No: LH0254829

Oil Type: EXTENDED LIFE COOLANT

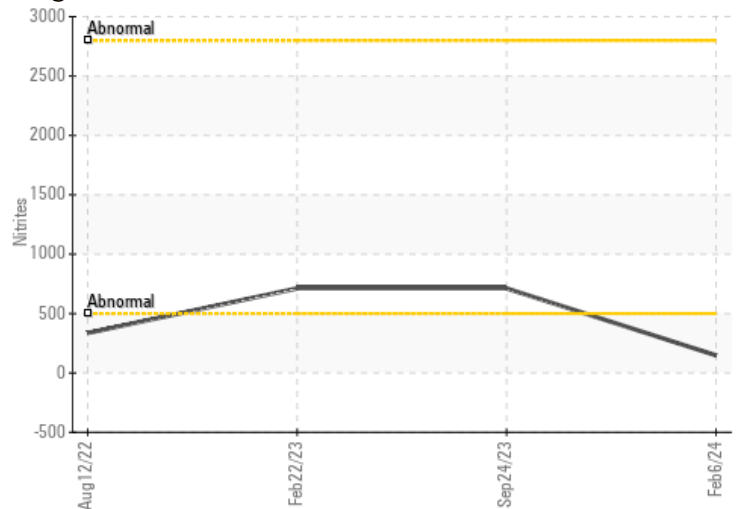
Nitrites

We advise that you replenish the supplemental coolant additives (SCAs) and add per manufacturer's recommendations. All metal levels are normal indicating no corrosion in the cooling system. There is no indication of any contamination in the coolant. Carboxylate test failed. The nitrite level is low. The glycol level is acceptable. The pH level of this fluid is within the acceptable limits.
