## LIEBHERR R924CHDSL 033185-1066 - Swing Drive

Sample No: LH0278403

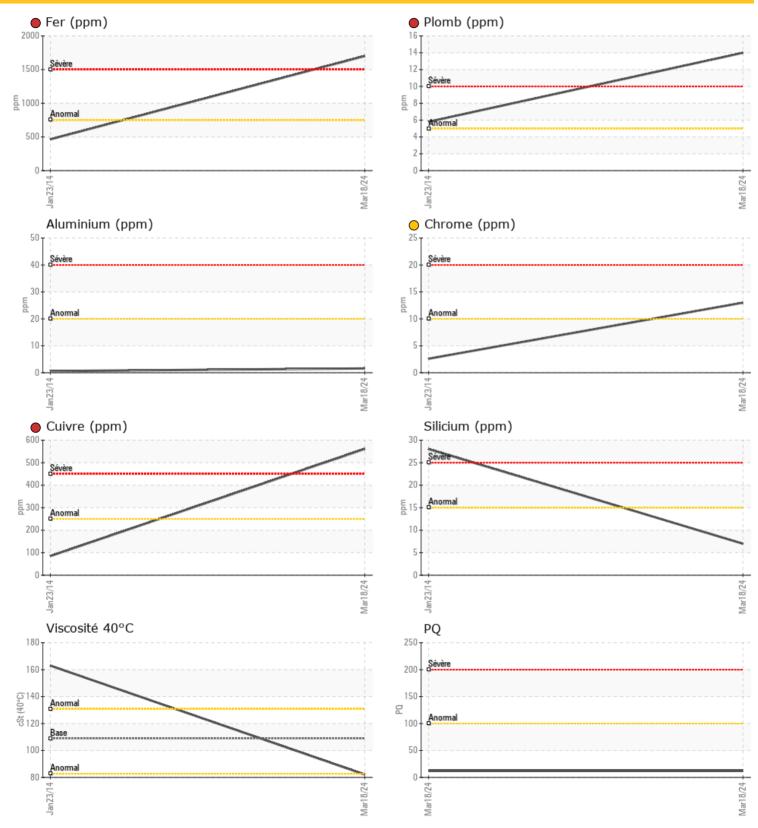
GRAPHS

The oil change at the time of sampling has been noted. We recommend an early resample to monitor this condition. The fluid was not specified, however, a fluid match indicates that this fluid is (GENERIC) GEAR OIL SAE 75W90. Please confirm.Copper, iron and lead ppm levels are severe. Tin and chromium ppm levels are abnormal. Bearing and/or bushing wear is indicated. The low ferrous density (PQ) index indicates the wear metal levels are due to corrosion. There is no indication of any contamination in the oil. The oil is no longer serviceable as a result of the abnormal and/or severe wear.
