PROBLEM SUMMARY

Area
TEAM 1
Machine Id
122553 Turbo Generator
Component
Hydraulic System
Fluid
PETRO CANADA TURBOFLO R&O 32 (1250 GAL)

Customer Id: CANDRY
Sample No.: PC0069918
Lab Number: 02591749
Test Package: IND 2

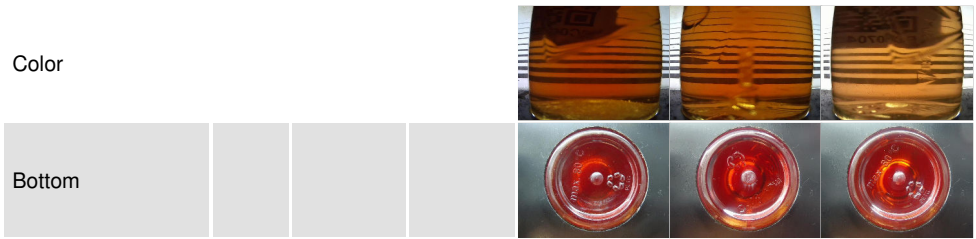
SAMPLE IMAGES	method	limit/base	current	history1	history2
---------------	--------	------------	---------	----------	----------

Contamination
Free water present. The system cleanliness is acceptable for your target ISO 4406 cleanliness code.

VISUAL	method	limit/base	current	history1	history2
White Metal	scalar	Visual*	NONE	NONE	NONE
Yellow Metal	scalar	Visual*	NONE	NONE	NONE
Precipitate	scalar	Visual*	NONE	NONE	NONE
Silt	scalar	Visual*	NONE	NONE	NONE
Debris	scalar	Visual*	NONE	VLITE	VLITE
Sand/Dirt	scalar	Visual*	NONE	NONE	NONE
Appearance	scalar	Visual*	NORML	▲ WGOIL	NORML
Odor	scalar	Visual*	NORML	NORML	NORML
Emulsified Water	scalar	Visual*	>0.05	.2%	NEG
Free Water	scalar	Visual*		▲ 1%	NEG

Recommendation
We advise that you check for the source of water entry. Check seals and/or filters for points of contaminant entry. The air breather requires service. If unrated, we recommend that you replace with a suitable micron rated and/or desiccant air breather. If rated, we recommend that you service/replace the breather. We advise that you follow the water drain-off procedure for this component. We recommend an early resample to monitor this condition. Please contact your representative for information regarding the proper sampling kits for your service. NOTE: We recommend using IND 3 test kits, this testkit includes Analytical Ferrography which provides a detailed morphological analysis of wear particles present in the fluid.
