PROBLEM SUMMARY

Area
[98272424]
 Machine Id
KR-GR-001552-SOUTH - 15000 LB MIXER (S/N MIX A - 11513053)
 Component
Gearbox
 Fluid
PETRO CANADA 220 (13 GAL)

OIL ANALYSIS REPORT

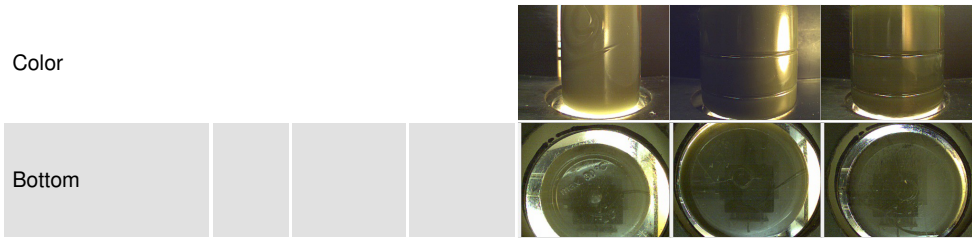
SAMPLE IMAGES		method	limit/base	current	history1	history2
---------------	--	--------	------------	---------	----------	----------

Appearance is hazy. There is a high concentration of water present in the oil.

We advise that you check for the source of water entry. We advise that you follow the water drain-off procedure for this component, and use off-line filtration to improve the cleanliness of the system fluid. We recommend an early resample to monitor this condition.
