Area
NAT CUTS [BEFORE]
Machine Id
LINE 2 CUBER
Component
Hydraulic System
Fluid
AW HYDRAULIC OIL ISO 460 (--- GAL)

Customer Id: KRASPRMO
Sample No.: PCA0100107
Lab Number: 05929564
Test Package: IND 2

OIL ANALYSIS REPORT

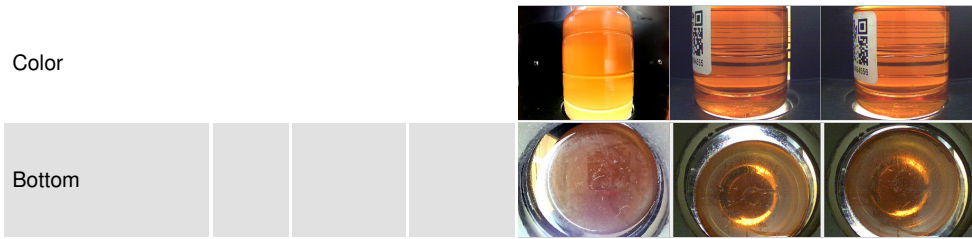
SAMPLE IMAGES

There is a moderate amount of visible silt present in the sample.

We recommend you service the filters on this component. Resample at the next service interval to monitor. We were unable to perform a particle count due to a high concentration of particles present in this sample.
