Machine Id
913036
 Component
Hydraulic System
 Fluid
PETRO CANADA HYDREX MV 46 (--- GAL)

Customer Id: GFL836
 Sample No.: GFL0122795
 Lab Number: 06193929
 Test Package: FLEET

OIL ANALYSIS REPORT

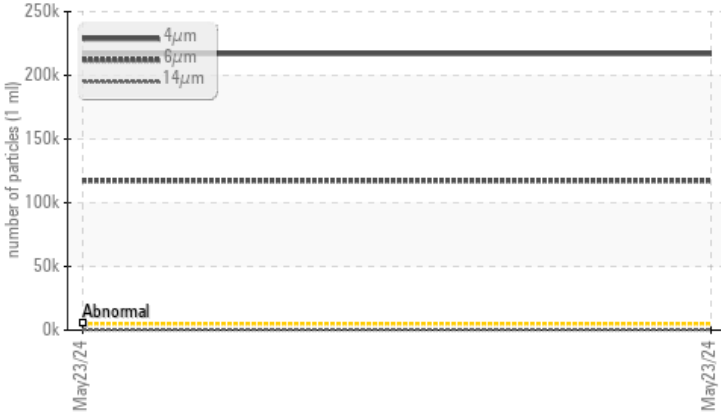
▲ Particle Trend

| Sample Status | | | SEVERE | --- | --- |
| Particles >4µm | ASTM D7647 | >5000 | ▲ 216964 | --- | --- |
| Particles >6µm | ASTM D7647 | >1300 | ▲ 117275 | --- | --- |
| Particles >14µm | ASTM D7647 | >160 | ▲ 407 | --- | --- |
| Oil Cleanliness | ISO 4406 (c) | >19/17/14 | ▲ 25/24/16 | --- | --- |

Check seals and/or filters for points of contaminant entry. The air breather requires service. If unrated, we recommend that you replace with a suitable micron rated and/or desiccant air breather. If rated, we recommend that you service/replace the breather. The filter change at the time of sampling has been noted. Resample in 30-45 days to monitor this situation.
