CONSTRUCTION EQUIPMENT

CAVANAGH 379797 VOLVO EC380EL 314111 - COOLANT

Sample No: VCP391731
Oil Type: NOT GIVEN
Job No: 379797

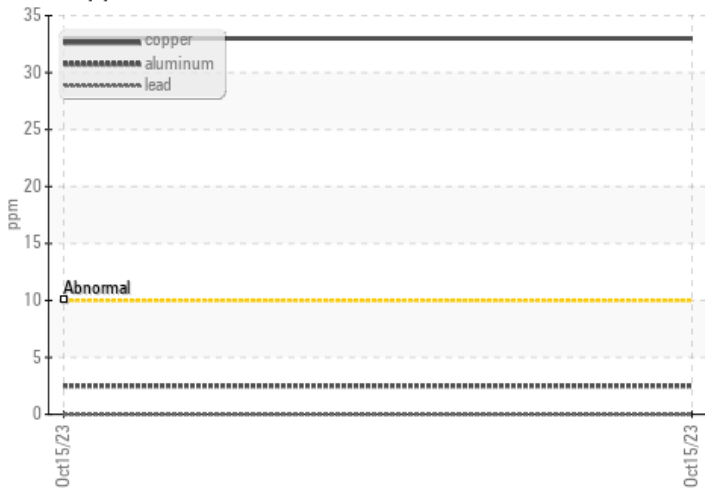
Copper/Aluminum/Lead

We recommend drain system, and refill with 50/50 antifreeze water mixture. We advise that you replenish the supplemental coolant additives (SCAs) and add per manufacturer's specifications. We recommend an early resample to monitor this condition. Copper ppm levels are abnormal. The high metal levels indicate corrosion in the system. There is no indication of any contamination in the coolant. The pH level of this fluid is within the acceptable limits. The reserve alkalinity of this fluid is acceptable.

Iron	ppm	0	---	---	---
Aluminum	ppm	2	---	---	---
Copper	ppm	33	---	---	---
Lead	ppm	0	---	---	---
Tin	ppm	0	---	---	---
