SWO921227 VOLVO A30G 75221 - BRAKE COOLING SYSTEM

Sample No: VCP337712
Oil Type: VOLVO WB 102
Job No: SWO921227

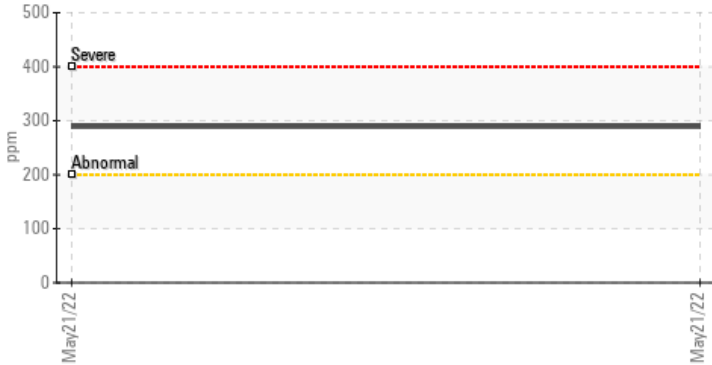
▲ Copper (ppm)

No corrective action is recommended at this time. Resample at the next service interval to monitor. The copper level is abnormal. All other component wear rates are normal. There is no indication of any contamination in the fluid. The condition of the fluid is acceptable for the time in service.
