# CONSTRUCTION EQUIPMENT

X10399 WOOTRU SAND VOLVO EC480EL 311036 - HYDRAULIC SYSTEM

**Sample No:** VCP423449  
**Oil Type:** VOLVO AW 68  
**Job No:** X10399 WOOTRU SAND

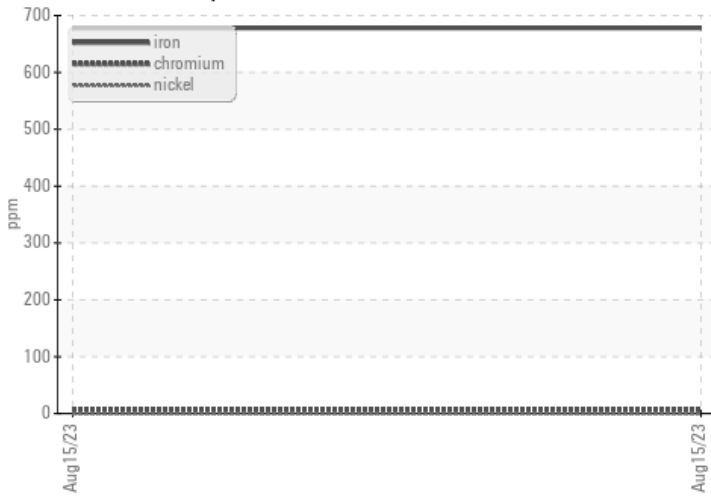
### ◆ Ferrous Alloys

HYDRAULIC PUMP FAILURE. The iron level is severe. There is a light concentration of water present in the oil. Moderate concentration of visible dirt/debris present in the oil. Viscosity of sample indicates oil is within ISO 46 range, advise investigate.
