CONSTRUCTION EQUIPMENT

VOLVO A45G 352969 - BRAKE

Sample No: VCP433939

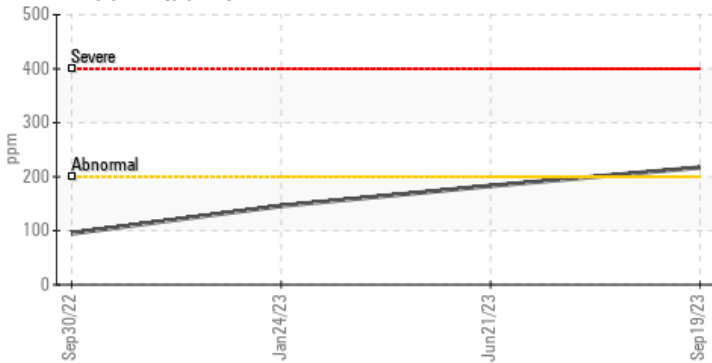
▲ Copper (ppm)

No corrective action is recommended at this time. Resample at the next service interval to monitor. The copper level is abnormal. All other component wear rates are normal. There is no indication of any contamination in the fluid. The condition of the fluid is acceptable for the time in service.
