VOLVO A25C 740205 - BRAKE COOLING SYSTEM

Sample No: VCP430272

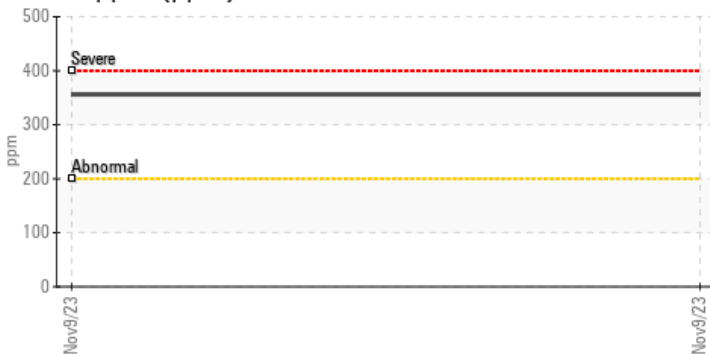
▲ Copper (ppm)

No corrective action is recommended at this time. Resample at the next service interval to monitor. Please specify the brand, type, and viscosity of the oil on your next sample. The copper level is abnormal. All other component wear rates are normal. There is no indication of any contamination in the fluid. The condition of the fluid is acceptable for the time in service.
