# CONSTRUCTION EQUIPMENT

7199 IMERYS VOLVO A30G 742635 - BRAKE

**Sample No:** VCP414683  
**Oil Type:** VOLVO WB 102  
**Job No:** 7199 IMERYS

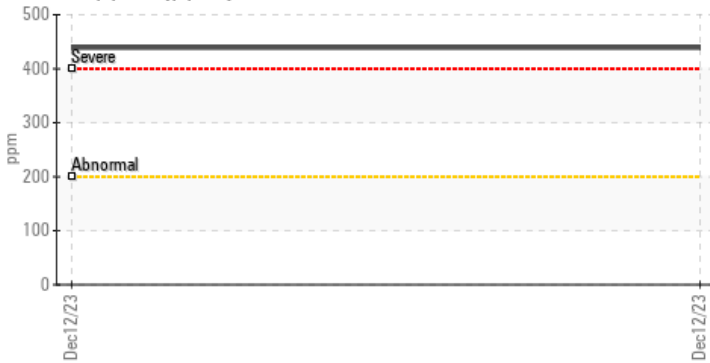
### ▲ Copper (ppm)

The fluid change at the time of sampling has been noted. No corrective action is recommended at this time. Resample at the next service interval to monitor. The copper level is abnormal. All other component wear rates are normal. There is no indication of any contamination in the fluid. The condition of the fluid is acceptable for the time in service.
