# CONSTRUCTION EQUIPMENT

SWO-070331 VOLVO A40F 11843 - COOLANT

**Sample No:** VCP452407  
**Oil Type:** VOLVO COOLANT VCS (YELLOW)  
**Job No:** SWO-070331

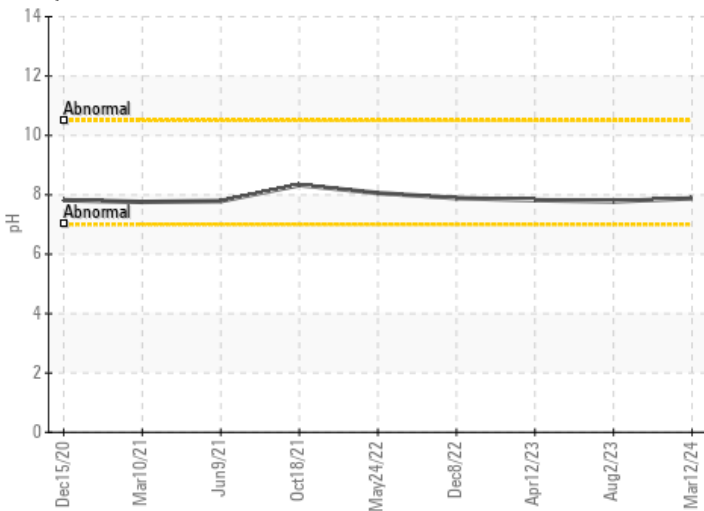
### pH

No corrective action is recommended at this time. The fluid is suitable for further service. There is no indication of any contamination in the coolant. Carboxylate test failed. The glycol level is acceptable. The pH level of this fluid is within the acceptable limits.
