702593 5729 VOLVO L180 5729 - TRANSMISSION (AUTO)

Sample No: VCP449808
Oil Type: VOLVO AUTOMATIC TRANSMISSION FLUID AT102
Job No: 702593

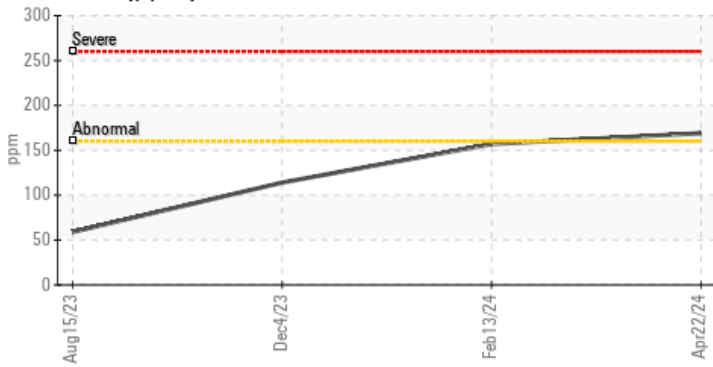
▲ Iron (ppm)

Diagnosis
 No corrective action is recommended at this time. Resample at the next service interval to monitor. The iron level is abnormal. All other component wear rates are normal. There is no indication of any contamination in the fluid. The condition of the fluid is acceptable for the time in service.
