702732 ATLAS ORGANIC VOLVO L70H 624287 - TRANSMISSION (AUTO)

Sample No: VCP447357
Oil Type: VOLVO AUTOMATIC TRANSMISSION FLUID AT102
Job No: 702732 ATLAS ORGANIC

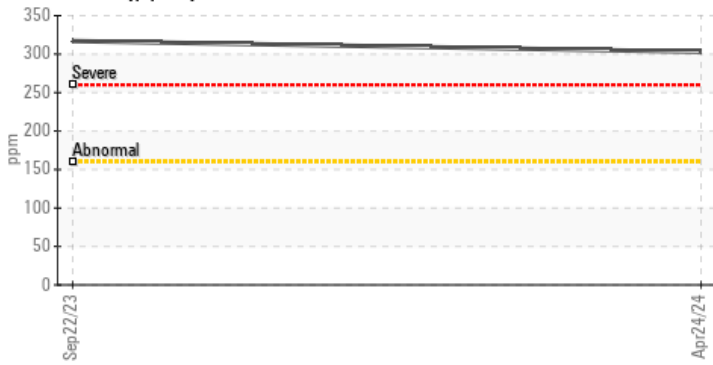
▲ Iron (ppm)

No corrective action is recommended at this time. Resample at the next service interval to monitor. The iron level is abnormal. All other component wear rates are normal. There is no indication of any contamination in the fluid. The condition of the fluid is acceptable for the time in service.
