HERC RENTAL VOLVO A30G 752902 - BRAKE COOLING SYSTEM

Sample No: VCP445549
Oil Type: VOLVO WB 101
Job No: HERC RENTAL

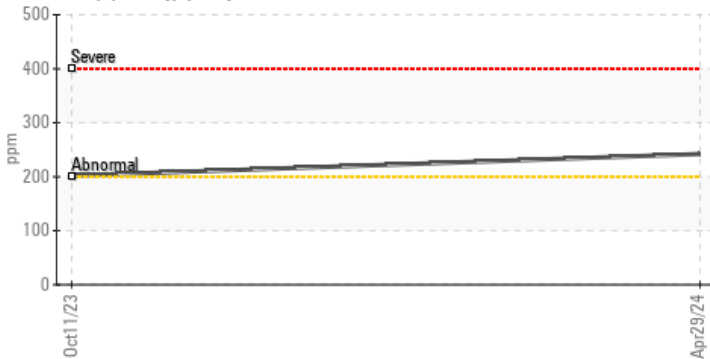
▲ Copper (ppm)

No corrective action is recommended at this time. Resample at the next service interval to monitor. The copper level is abnormal. All other component wear rates are normal. There is no indication of any contamination in the fluid. The condition of the fluid is acceptable for the time in service.
