SWA536475-10 VOLVO L220H 2823 - TRANSMISSION (AUTO)

Sample No: VCP430293
Oil Type: VOLVO AT 102
Job No: SWA536475-10

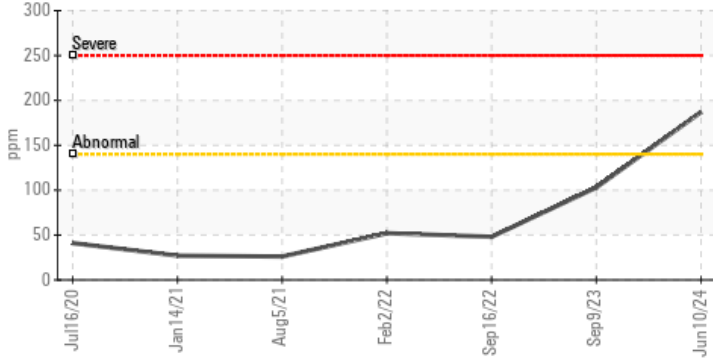
▲ Iron (ppm)

No corrective action is recommended at this time. Resample at the next service interval to monitor. The iron level is abnormal. All other component wear rates are normal. There is no indication of any contamination in the fluid. The condition of the fluid is acceptable for the time in service.
