CONSTRUCTION EQUIPMENT

VOLVO L60H 632294 - TRANSMISSION

Sample No: VCP442208

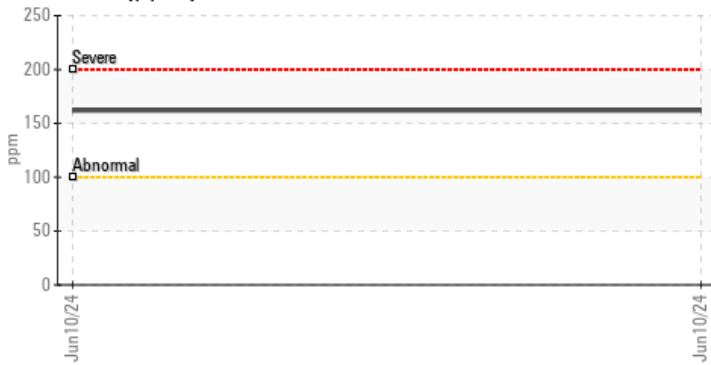
▲ Iron (ppm)

Iron	ppm	▲ 162	---	---	---
Copper	ppm	█ 9	---	---	---
Lead	ppm	█ <1	---	---	---
Tin	ppm	█ <1	---	---	---
Aluminum	ppm	█ 3	---	---	---
Chromium	ppm	█ <1	---	---	---
Molybdenum	ppm	█ <1	---	---	---
Nickel	ppm	█ <1	---	---	---
Titanium	ppm	0	---	---	---
Silver	ppm	0	---	---	---
Manganese	ppm	█ 8	---	---	---
Vanadium	ppm	0	---	---	---

No corrective action is recommended at this time. Resample at the next service interval to monitor. The iron level is abnormal. All other component wear rates are normal. There is no indication of any contamination in the fluid. The condition of the fluid is acceptable for the time in service.
