## **OIL ANALYSIS REPORT**

## **PORT - PORT MAIN ENGINE**

Sample No:VPA053525Oil Type:SHELL ROTELLA T 15W40

**1000 ISLANDS CRUISES** 248 ONTARIO ST

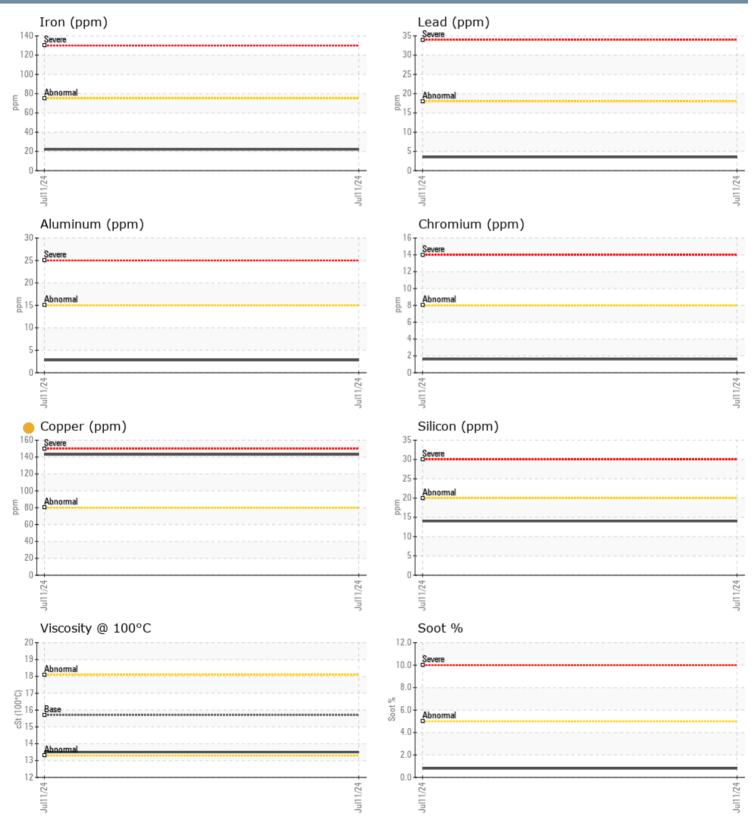
#### GRAPHS

The oil change at the time of sampling has been noted. We recommend an early resample to monitor this condition. Please specify the component make and model with your next sample.Nickel ppm levels are abnormal. Copper ppm levels are noted. Exhaust valve wear is indicated. In the absence of other significant wear metals, suspect copper due to sources other than wear (i.e. cooling core). There is no indication of any contamination in the oil. The oil is no longer serviceable as a result of the abnormal and/or severe wear.
