Area
TC01
 Machine Id
TC01 10 Inch Top

Component
Gearbox
 Fluid
TRIBOL GEAROIL 1100/320 (--- LTR)

Customer Id: GOONAP
 Sample No.: WC22086776
 Lab Number: 01670697
 Test Package: IND 2

OIL ANALYSIS REPORT

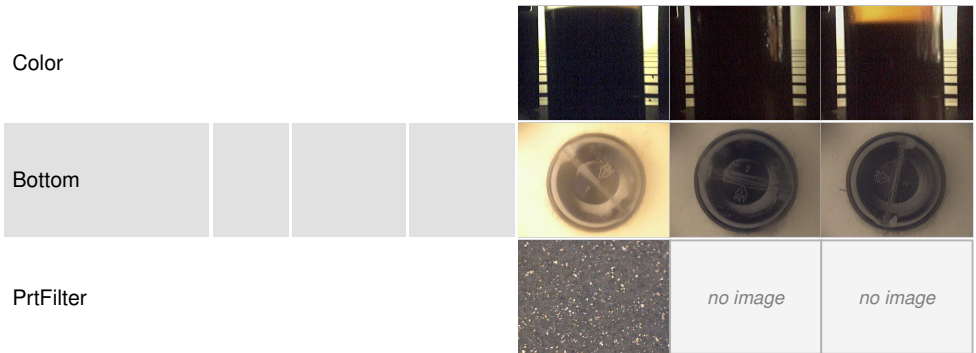
SAMPLE IMAGES	method	limit/base	current	history1	history2
---------------	--------	------------	---------	----------	----------

A sharp increase in the iron level is noted. Light concentration of visible metal present. Gear wear is indicated.

VISUAL	method	limit/base	current	history1	history2	
White Metal	scalar	Visual*	NONE	▲ MODER	LIGHT	LTMOD
Yellow Metal	scalar	Visual*	NONE	NONE	NONE	NONE
Precipitate	scalar	Visual*	NONE	NONE	NONE	NONE
Silt	scalar	Visual*	NONE	LTMOD	NONE	NONE
Debris	scalar	Visual*	NONE	NONE	NONE	NONE
Sand/Dirt	scalar	Visual*	NONE	NONE	NONE	NONE
Appearance	scalar	Visual*	NORML	NORML	NORML	NORML
Odor	scalar	Visual*	NORML	NORML	NORML	NORML
Emulsified Water	scalar	Visual*	NEG	NEG	NEG	NEG
Free Water	scalar	Visual*	NEG	NEG	NEG	NEG

We recommend that you drain the oil from the component if this has not already been done. We recommend an early resample to monitor this condition.
