Area
MANITOU FALLS GS
 Machine Id
FP2G4
 Component
Thrust Bearing
 Fluid
ESSO TERESSO ISO 46 (--- GAL)

Customer Id: ONTKEE
 Sample No.: WC0806469
 Lab Number: 02559004
 Test Package: IND 2

OIL ANALYSIS REPORT

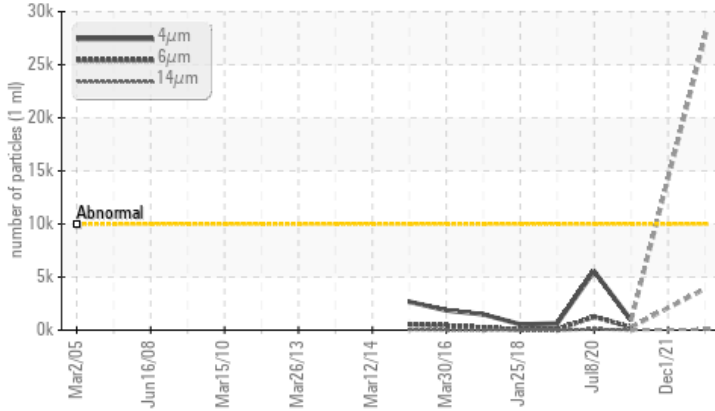
▲ Particle Trend

Sample Status			ABNORMAL	ABNORMAL	NORMAL
Particles >4µm	ASTM D7647	>10000	▲ 27641	---	939
Particles >6µm	ASTM D7647	>2500	▲ 3906	---	276
Oil Cleanliness	ISO 4406 (c)	>20/18/14	▲ 22/19/14	---	17/15/12

We recommend you service the filters on this component. We recommend an early resample to monitor this condition. NOTE: Please provide information regarding reservoir capacity, filter type and micron rating with next sample.

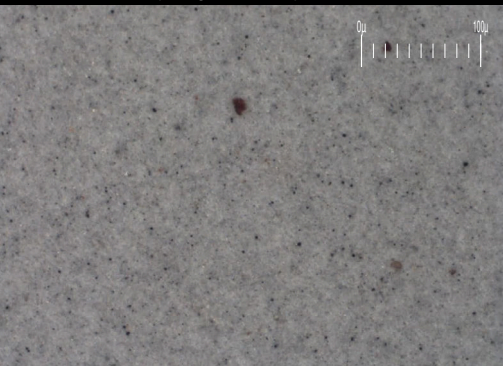
Particle Filter (Magn: 200 x)

There is a moderate amount of silt (particulates < 14 microns in size) present in the oil.

We recommend you service the filters on this component. We recommend an early resample to monitor this condition. NOTE: Please provide information regarding reservoir capacity, filter type and micron rating with next sample.
