# PROBLEM SUMMARY

Machine Id  
**059**  
 Component  
**Hydraulic System**  
 Fluid  
**ESSO HYJET IV-A PLUS (--- GAL)**

Customer Id: KELMOU  
 Sample No.: WC0838479  
 Lab Number: 02575918  
 Test Package: IND 2

# OIL ANALYSIS REPORT

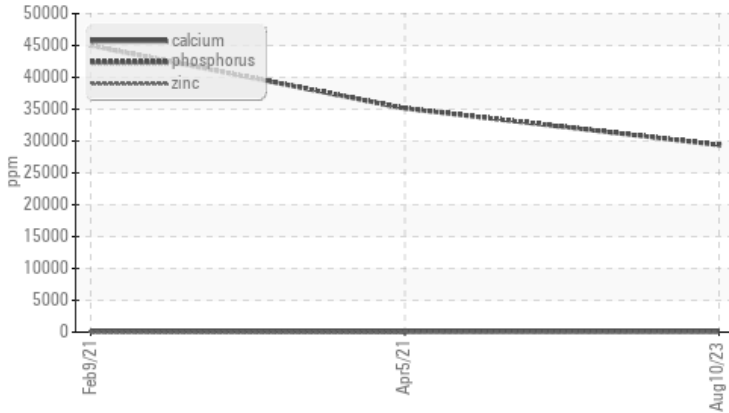
#### ▲ Additives

Sample Status				ATTENTION	ABNORMAL	NORMAL
Phosphorus	ppm	ASTM D5185(m)	37	▲ 29387	▲ 35127	44986
Sulfur	ppm	ASTM D5185(m)	220	▲ 594	▲ 798	336

Additive levels indicate the addition of a different brand, or type of oil. The AN level is acceptable for this fluid. The condition of the oil is suitable for further service.

Confirm the source of the lubricant being utilized for top-up/fill. Resample at the next service interval to monitor. NOTE: Please provide information regarding reservoir capacity, filter type and micron rating with next sample.
