# PROBLEM SUMMARY

Area  
**SAB1**  
 Machine Id  
**SAB1 G5**  
 Component  
**Thrust Bearing**  
 Fluid  
**PETRO CANADA TURBOFLO XL46 (1182 LTR)**

# OIL ANALYSIS REPORT

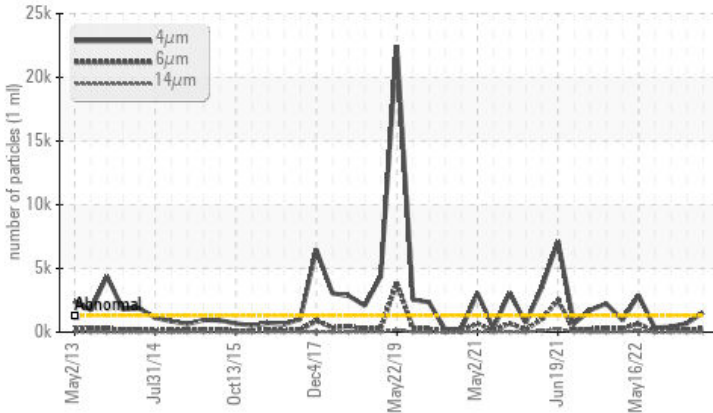
▲ Particle Trend

Sample Status				<b>ABNORMAL</b>	NORMAL	NORMAL
Particles >4µm	ASTM D7647	>1300		▲ <b>1529</b>	689	412
Oil Cleanliness	ISO 4406 (c)	>17/15/12		▲ <b>18/15/10</b>	17/15/11	16/14/11
White Metal	scalar	Visual*	NONE	▲ <b>LIGHT</b>	NONE	NONE

We advise that you check for visible metal particles in the oil. We recommend you service the filters on this component. We recommend an early resample to monitor this condition.

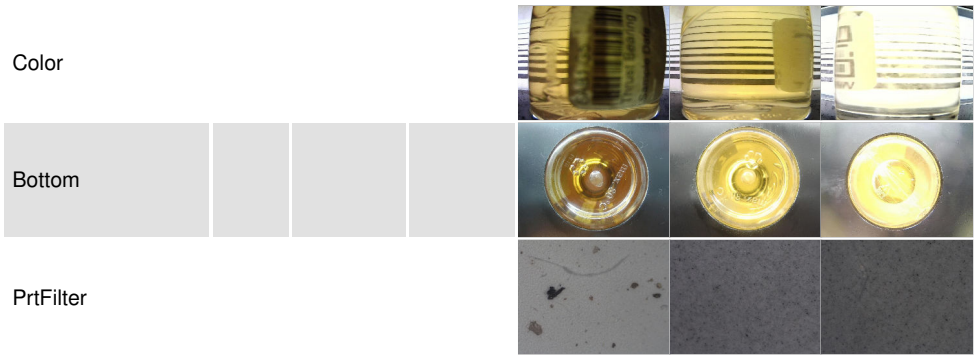
SAMPLE IMAGES	method	limit/base	current	history1	history2
---------------	--------	------------	---------	----------	----------

Light concentration of visible metal present.

There is a light amount of silt (particulates < 14 microns in size) present in the oil.

We advise that you check for visible metal particles in the oil. We recommend you service the filters on this component. We recommend an early resample to monitor this condition.
