Area
PLANT 7
 Machine Id
AHS SLT
 Component
1 Hydraulic System
 Fluid
COMMERCIAL OIL LUBRIKO AW 46 (100 LTR)

Customer Id: TAYSTO
 Sample No.: WC0754607
 Lab Number: 02590007
 Test Package: IND 2

OIL ANALYSIS REPORT

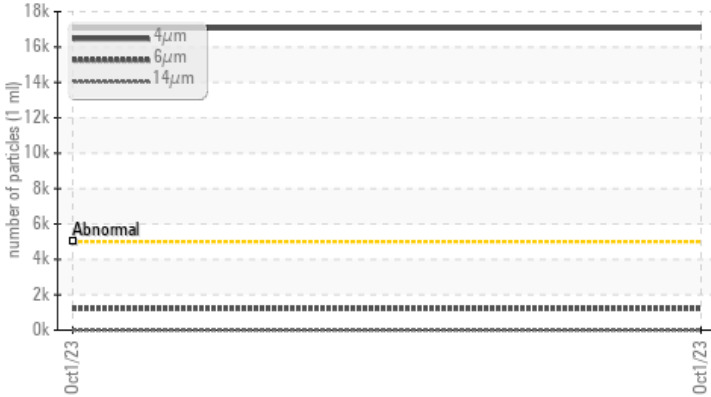
▲ Particle Trend

Sample Status				ABNORMAL	---	---
Particles >4µm		ASTM D7647	>5000	▲ 17061	---	---
Oil Cleanliness		ISO 4406 (c)	>19/17/14	▲ 21/17/9	---	---
White Metal	scalar	Visual*	NONE	▲ VLITE	---	---
Debris	scalar	Visual*	NONE	▲ VLITE	---	---
PrtFilter

We advise that you check all areas where contaminants can enter the system. We recommend you service the filters on this component. We recommend an early resample to monitor this condition. Please specify the component make and model with your next sample. We suspect that the abnormal contaminant(s) is the result of incorrect sampling technique. **DISCLAIMER:** Interpretation of results is based on the sample as received from the customer. The condition of the sample and the method of sampling cannot be verified.
