Machine Id
VOLVO EC160EL P96 (S/N VCEC160EK00310367)
 Component
Hydraulic System
 Fluid
PANOLIN HLP SYNTH 46 (--- GAL)

Customer Id: CLESAL
 Sample No.: WC0843720
 Lab Number: 02590078
 Test Package: IND 2

OIL ANALYSIS REPORT

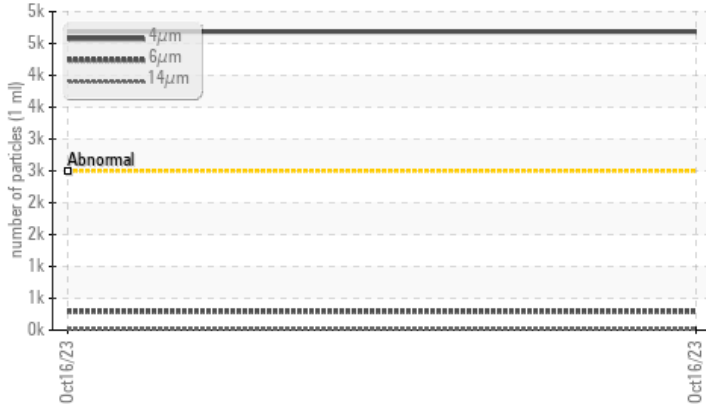
▲ Particle Trend

Sample Status	ATTENTION	---	---
Particles >4µm	ASTM D7647 >2500 ▲ 4685	---	---
Oil Cleanliness	ISO 4406 (c) >18/16/13 ▲ 19/15/11	---	---

Nous recommandons le remplacement des filtres de ce composant. Échantillonner de nouveau l'équipement au prochain intervalle de vidange afin d'en surveiller la condition. À NOTER: S.V.P. inclure, avec le prochain échantillon, des détails de la capacité du réservoir et le type et le degré de filtration.
