OIL ANALYSIS REPORT

Area
SAB2
 Machine Id
SAB2 G23
 Component
Turbine Bearing
 Fluid
ESSO TERESSO ISO 46 (273 LTR)

Ontario Power Generation
 NIAGARA PLANT GROUP, 14000 NIAGARA PKWY
 NIAGARA ON THE LAKE, ON
 CA L0S 1J0
 Contact: Alex Courtemanche
 alex.courtemanche@opg.com
 T: (905)357-0322
 F: (905)357-6558

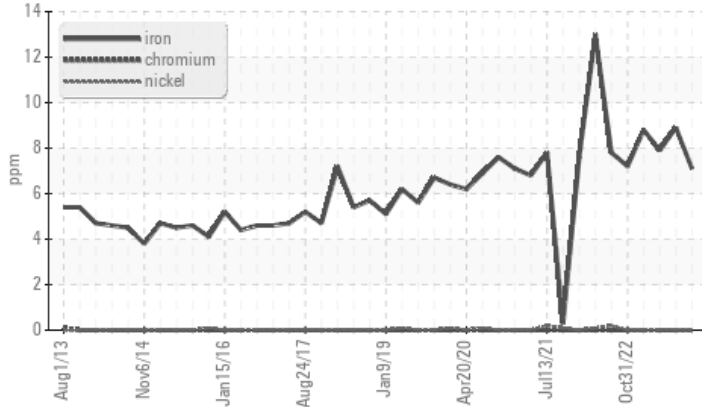
▲ Ferrous Alloys

Sample Status				ATTENTION	ABNORMAL	ABNORMAL
Iron	ppm	ASTM D5185(m)	>7	▲ 7	▲ 9	▲ 8

Resample at the next service interval to monitor.

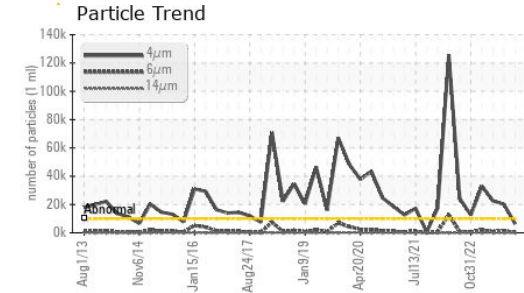
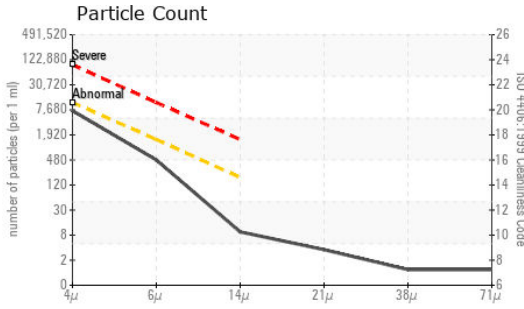
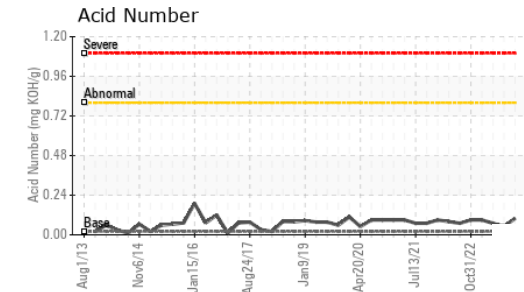
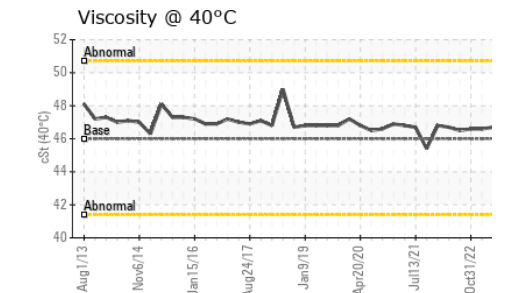
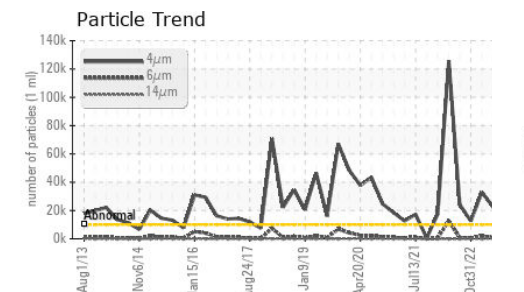
Wear
 Iron ppm levels are noted. All other component wear rates are normal.

Contamination
 The system cleanliness is acceptable for your target ISO 4406 cleanliness code. The system and fluid cleanliness is acceptable.

Recommendation
 Resample at the next service interval to monitor.
