# PROBLEM SUMMARY

Area  
**TURRET**  
 Machine Id  
**91-X-9605 SWIVEL 6, 12**  
 Component  
**Sealing System**  
 Fluid  
**MOBIL MOBILGEAR 634 (--- GAL)**

# OIL ANALYSIS REPORT

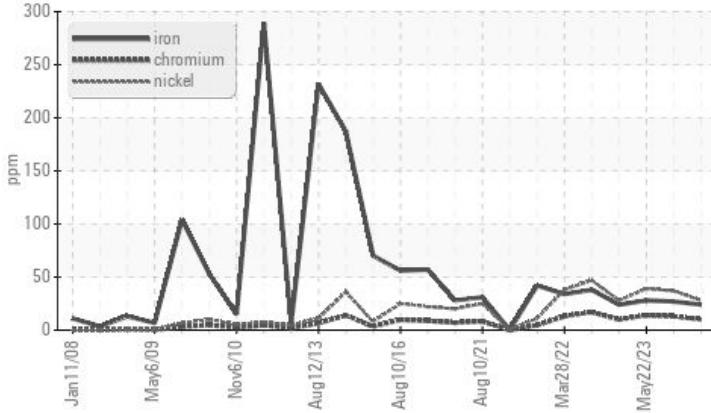
▲ Ferrous Alloys

Chromium and nickel ppm levels are abnormal.

Check seals and/or filters for points of contaminant entry. We recommend either performing an oil change or oil filtration. We cannot recommend specific action as we have limited information with regards to reservoir capacity and/or lubricant type. The air breather requires service. If unrated, we recommend that you replace with a suitable micron rated and/or desiccant air breather. If rated, we recommend that you service/replace the breather. We recommend an early resample to monitor this condition. NOTE: Please provide information regarding reservoir capacity, filter type and micron rating with next sample.

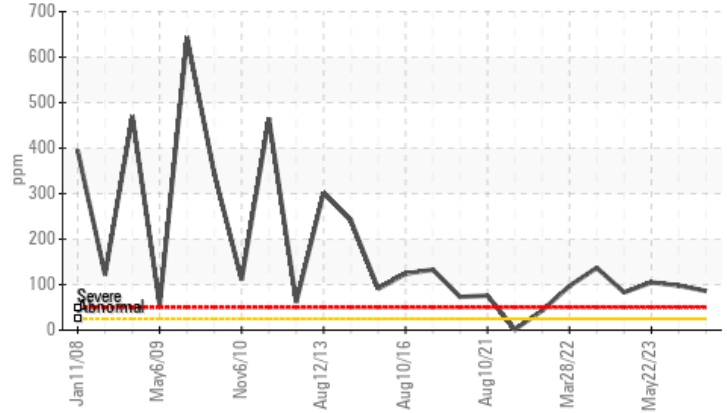
▲ Silicon (ppm)

Elemental level of silicon (Si) above normal indicating ingress of seal material.
