PROBLEM SUMMARY

Area
[412827297]
 Machine Id
Viscera Table Upper Gearbox
 Component
Gearbox
 Fluid
KLUBER KLUBEROIL 4 UH1-460 N (--- GAL)

Customer Id: CARGUE
 Sample No.: WC0881695
 Lab Number: 02601064
 Test Package: IND 2

OIL ANALYSIS REPORT

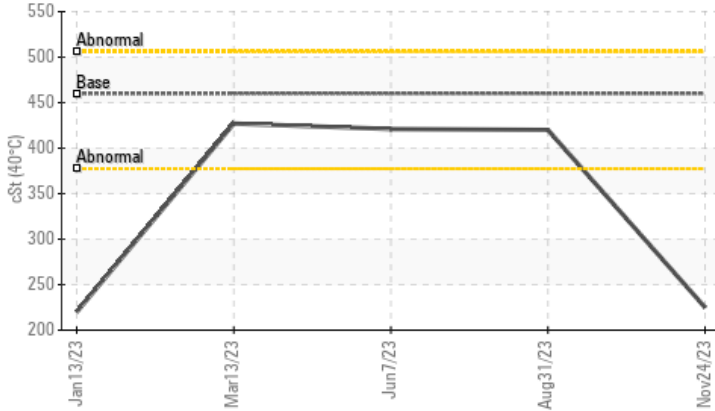
▲ Viscosity @ 40°C

Sample Status				ABNORMAL	ABNORMAL	NORMAL
Visc @ 40°C	cSt	ASTM D7279(m)	460	▲ 225	420	421

Viscosity of sample indicates oil is within ISO 220 range, advise investigate. The AN level is acceptable for this fluid. The condition of the oil is suitable for further service.

Due to this condition we recommend the following action... We advise an early resample to confirm this situation. NOTE: The current sample results do not match this units historical trend, indicating the sample may not be from this component/unit.

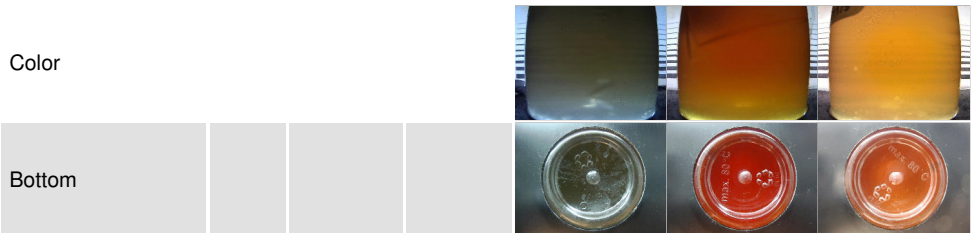
SAMPLE IMAGES	method	limit/base	current	history1	history2
---------------	--------	------------	---------	----------	----------

VISUAL	method	limit/base	current	history1	history2
White Metal	scalar	Visual*	NONE	NONE	NONE
Yellow Metal	scalar	Visual*	NONE	NONE	NONE
Precipitate	scalar	Visual*	NONE	NONE	VLITE
Silt	scalar	Visual*	NONE	NONE	NONE
Debris	scalar	Visual*	NONE	NONE	NONE
Sand/Dirt	scalar	Visual*	NONE	NONE	NONE
Appearance	scalar	Visual*	NORML	NORML	▲ WGOIL
Odor	scalar	Visual*	NORML	NORML	NORML
Emulsified Water	scalar	Visual*	>0.2	NEG	NEG
Free Water	scalar	Visual*		NEG	▲ 1%
