# OIL ANALYSIS REPORT

Machine Id  
**HEAD STR PRESS #1**

Component  
**Hydraulic System**

Fluid  
**AW HYDRAULIC OIL ISO 46 (116 GAL)**

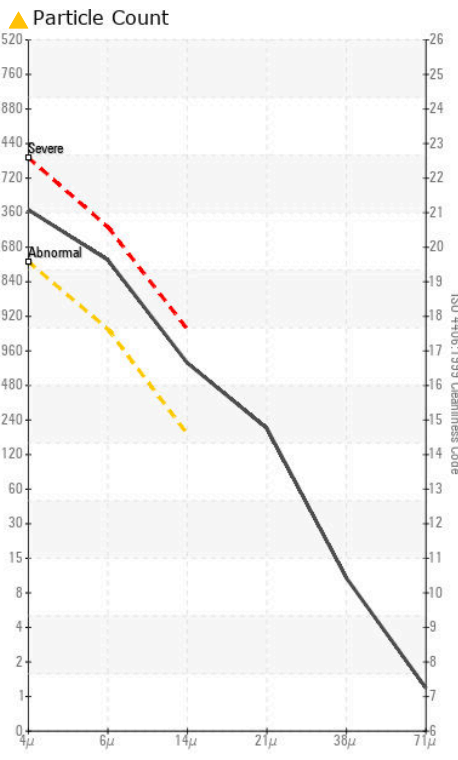
## GRAPHS

Oil Cleanliness are abnormally high. Particles >14µm are abnormally high. Particles >21µm are abnormally high. Particles >4µm are abnormally high. Particles >6µm are abnormally high.

This is a baseline read-out on the submitted sample.
