PROBLEM SUMMARY

Area
2 Phoenix/007 Hydrobon/Plat/C Compressor/1B Recycle/Makeup
 Machine Id
N/A 07GC1B
 Component
Gearbox
 Fluid
PETRO CANADA TURBOFLO 68 (400 LTR)

OIL ANALYSIS REPORT

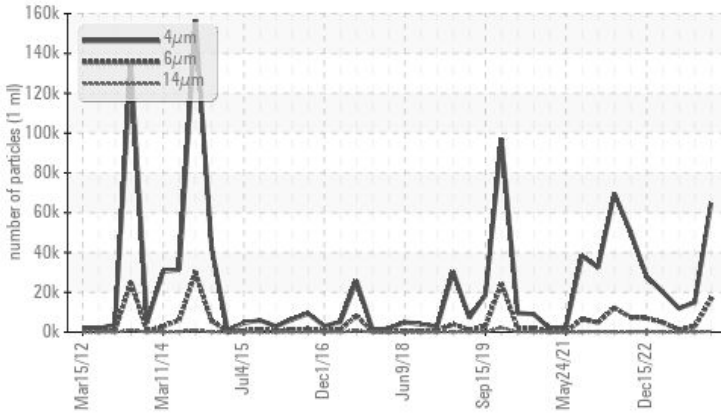
▲ Particle Trend

Sample Status		ABNORMAL	NORMAL	ABNORMAL
Particles >6µm	ASTM D7647 >5000	▲ 16433	2893	1160
Oil Cleanliness	ISO 4406 (c) >-/19/16	▲ 23/21/16	21/19/14	21/17/10

There is a moderate amount of silt (particulates < 14 microns in size) present in the oil. The system cleanliness is above the acceptable limit for the target ISO 4406 cleanliness code.

We recommend you service the filters on this component. We recommend an early resample to monitor this condition.

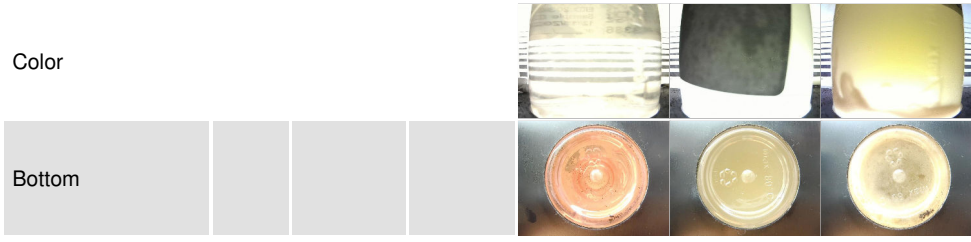
SAMPLE IMAGES		method	limit/base	current	history1	history2
---------------	--	--------	------------	---------	----------	----------

VISUAL		method	limit/base	current	history1	history2
White Metal	scalar	Visual*	NONE	NONE	NONE	NONE
Yellow Metal	scalar	Visual*	NONE	NONE	NONE	NONE
Precipitate	scalar	Visual*	NONE	NONE	NONE	NONE
Silt	scalar	Visual*	NONE	NONE	NONE	NONE
Debris	scalar	Visual*	NONE	VLITE	NONE	NONE
Sand/Dirt	scalar	Visual*	NONE	NONE	NONE	NONE
Appearance	scalar	Visual*	NORML	NORML	NORML	▲ WGOIL
Odor	scalar	Visual*	NORML	NORML	NORML	NORML
Emulsified Water	scalar	Visual*	>0.2	NEG	.2%	.5%
Free Water	scalar	Visual*		NEG	NEG	▲ 5%
