OIL ANALYSIS REPORT

Machine Id
PM2-225-25
 Component
Hydraulic System
 Fluid
{not provided} (--- GAL)

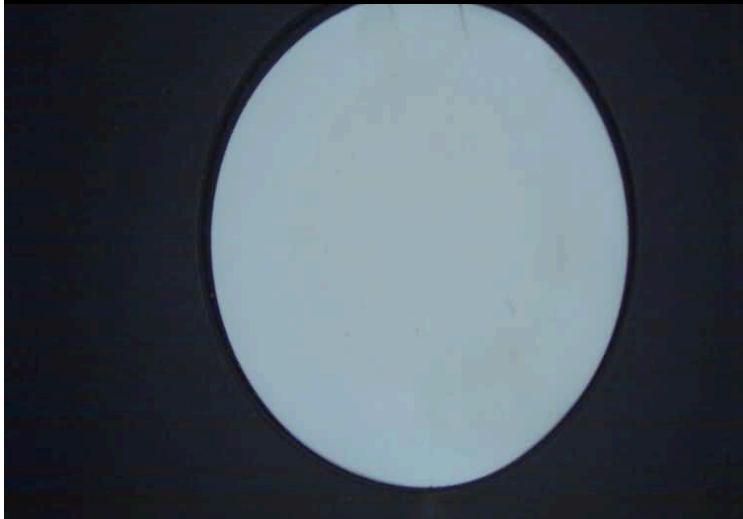
MPC (Varnish Test)

MPC (Membrane Patch Colorimetry) test indicates acceptable levels of varnish present.

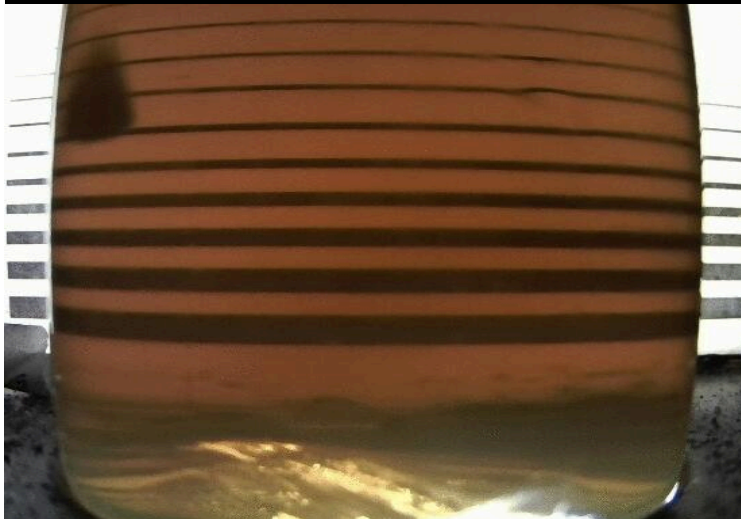
Sample Color & Clarity

VISUAL		method	limit/base	current	history1	history2
White Metal	scalar	Visual*	NONE	NONE	---	---
Yellow Metal	scalar	Visual*	NONE	NONE	---	---
Precipitate	scalar	Visual*	NONE	NONE	---	---
Silt	scalar	Visual*	NONE	NONE	---	---
Debris	scalar	Visual*	NONE	NONE	---	---
Sand/Dirt	scalar	Visual*	NONE	NONE	---	---
Appearance	scalar	Visual*	NORML	NORML	---	---
Odor	scalar	Visual*	NORML	NORML	---	---
