OIL ANALYSIS REPORT

Area
Hyd. shack # 2
 Machine Id
Q400#1 (S/N 8424)
 Component
Hydraulic System
 Fluid
ESSO NUTO H ISO 32 (200 GAL)

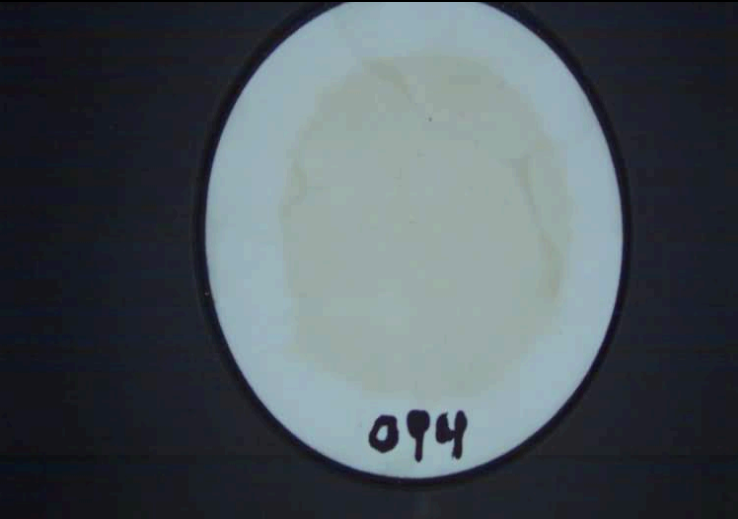
MPC (Varnish Test)

MPC (Membrane Patch Colorimetry) test indicates acceptable levels of varnish present.

FLUID DEGRADATION		method	limit/base	current	history1	history2
MPC Varnish Potential	Scale	ASTM D7843(m)*	>15	8	▲ 63	---

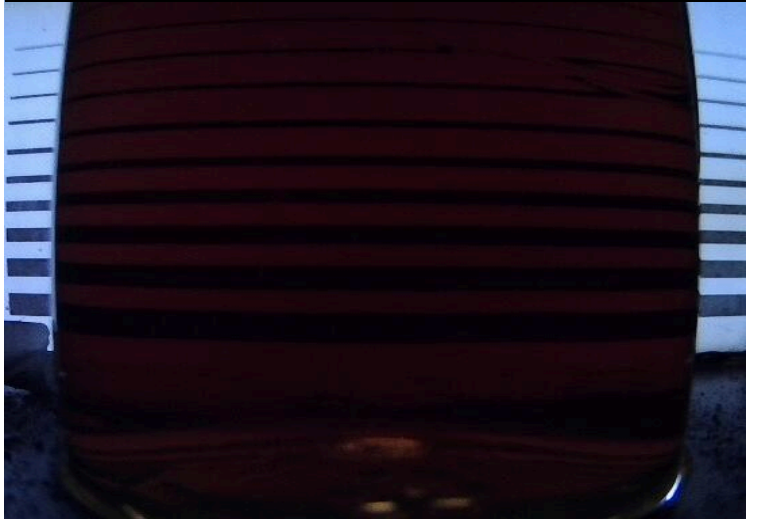
Sample Color & Clarity

VISUAL		method	limit/base	current	history1	history2
White Metal	scalar	Visual*	NONE	NONE	NONE	NONE
Yellow Metal	scalar	Visual*	NONE	NONE	NONE	NONE
Precipitate	scalar	Visual*	NONE	NONE	NONE	NONE
Silt	scalar	Visual*	NONE	NONE	NONE	NONE
Debris	scalar	Visual*	NONE	NONE	NONE	NONE
Sand/Dirt	scalar	Visual*	NONE	NONE	NONE	NONE
Appearance	scalar	Visual*	NORML	NORML	NORML	NORML
Odor	scalar	Visual*	NORML	NORML	NORML	NORML
