OIL ANALYSIS REPORT

Hyd. shack # 2

Q400#1 (S/N 8424)

Hydraulic System

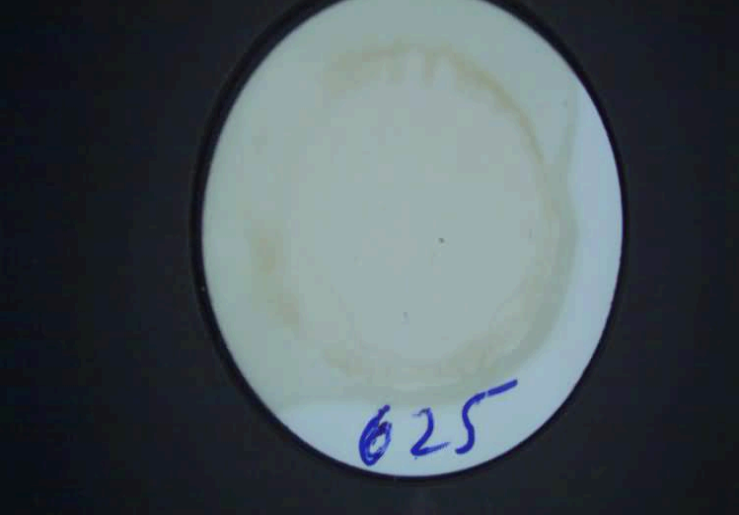
MPC (Varnish Test)

MPC (Membrane Patch Colorimetry) test indicates acceptable levels of varnish present.
