# PROBLEM SUMMARY

Machine Id  
**VACUUM DEGASSER PUMP**  
 Component  
**Hydraulic System**  
 Fluid  
**SHELL TELLUS S2 MX 46 (15000 GAL)**

# OIL ANALYSIS REPORT

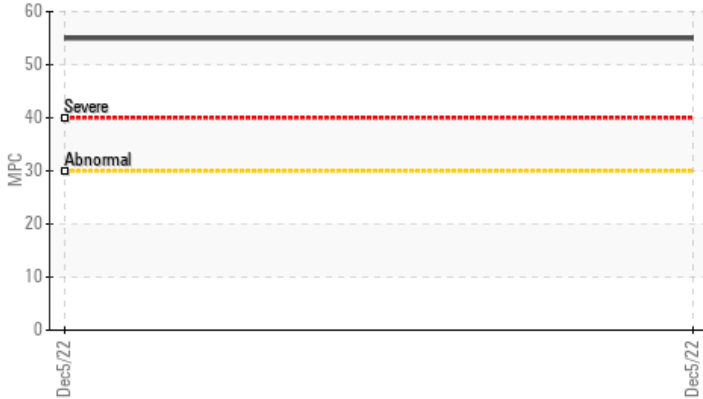
### ▲ Varnish Potential

Sample Status				<b>SEVERE</b>	---	---
MPC Varnish Potential	Scale	ASTM D7843	>15	▲ 55	---	---

We recommend that you use depth filtration to remove insolubles from the oil and to reduce the levels of varnish in the system. Alternatively draining a percentage of the oil and topping up with fresh oil (sweetening the oil) may provide a reduction in the varnish potential level. We recommend an early resample to monitor this condition. Additional phone discussion regarding this analysis included information that the spot test for varnish on the MPC indicated that not all of the varnish components are purely varnish. Pure varnish will react to the test chemical and this MPC did not react as typical for varnish, suggesting there is a secondary process happening in the lubricant creating solids such as ash or a chemical conversion to another chemical or polymer that is insoluble. This may be a result of mixing lubricant with incompatible additives, or may be a result of a combustion process such as filtration static arcing or microdieseling. Please note that this is a corrected copy of this report to include additional commentary to document phone conversation points.

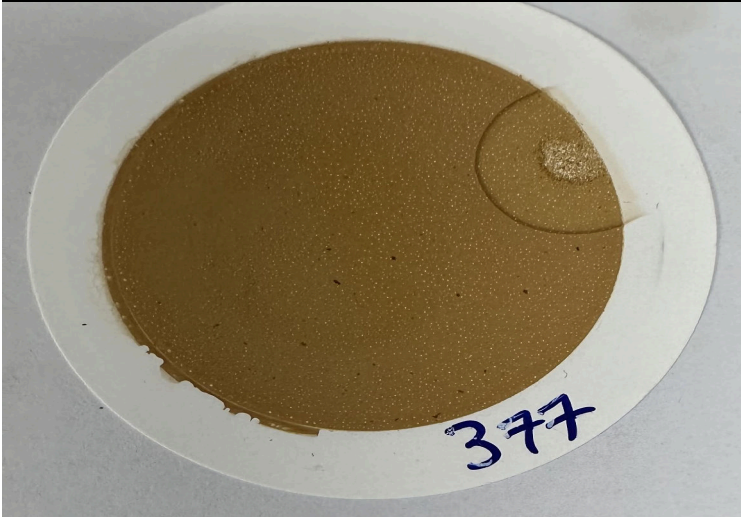
MPC (Varnish Test)

FLUID DEGRADATION		method	limit/base	current	history1	history2
Acid Number (AN)	mg KOH/g	ASTM D8045		<b>0.33</b>	---	---
Anti-Oxidant 1	%	ASTM D6971	<25	<b>69</b>	---	---
Anti-Oxidant 2	%	ASTM D6971	<25	<b>67</b>	---	---
Anti-Oxidant 3	%	ASTM D6971	<25	<b>158</b>	---	---
MPC Varnish Potential	Scale	ASTM D7843	>15	<b>▲ 55</b>	---	---
