# PROBLEM SUMMARY

Area  
**BATCH SYSTEM 7**  
 Machine Id  
**BS7NA HOMOGENIZER CRANKCASE**  
 Component  
**Gearbox**  
 Fluid  
**PETRO CANADA PURITY FG SYN GEAR ISO 220 (--- LTR)**

# OIL ANALYSIS REPORT

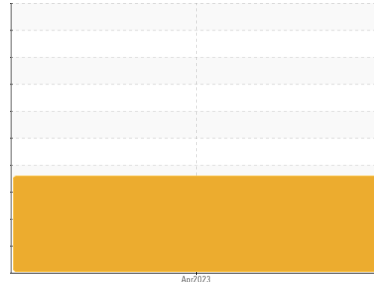
## Sample Rating Trend

**WATER**

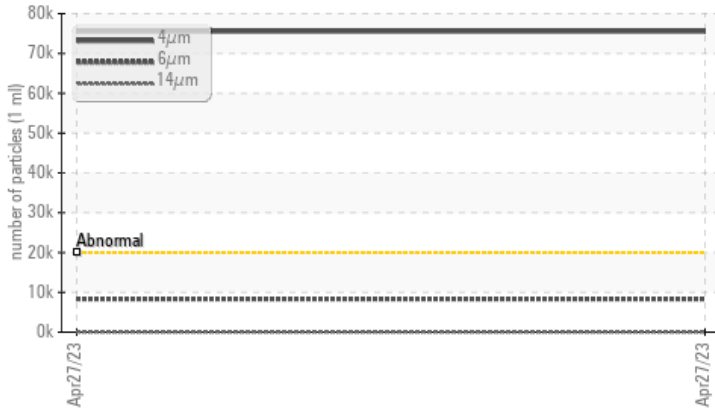
### ▲ Particle Trend

Sample Status				<b>ABNORMAL</b>	---	---
Particles >4µm	ASTM D7647	>20000	▲ <b>75549</b>	---	---	---
Particles >6µm	ASTM D7647	>5000	▲ <b>8327</b>	---	---	---
Oil Cleanliness	ISO 4406 (c)	>21/19/16	▲ <b>23/20/13</b>	---	---	---
Appearance	scalar	*Visual	NORML	▲ <b>HAZY</b>	---	---
Free Water	scalar	*Visual		▲ <b>1.0</b>	---	---

We advise that you check for the source of water entry. We advise that you follow the water drain-off procedure for this component. Resample at the next service interval to monitor.
