Customer Id: OUTCALAL
 Sample No.: RP0034906
 Lab Number: 05873929
 Test Package: IND 2

OIL ANALYSIS REPORT

Area
HAPL CRANES
 Machine Id
10.1 CRANE - WEST BRIDGE
 Component
Gearbox
 Fluid
NOT GIVEN (--- GAL)

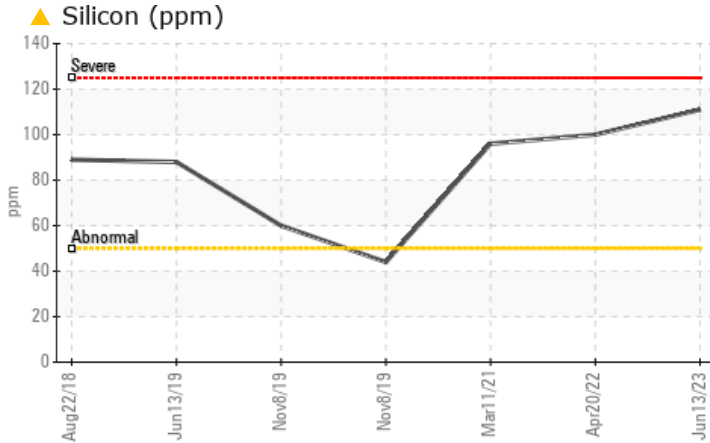
COMPONENT CONDITION SUMMARY

Sample Status	ABNORMAL	ABNORMAL	ABNORMAL
Silicon	ppm	ASTM D5185m	>50
	▲ 111	▲ 100	▲ 96

No corrective action is recommended at this time.
 Resample at the next service interval to monitor.

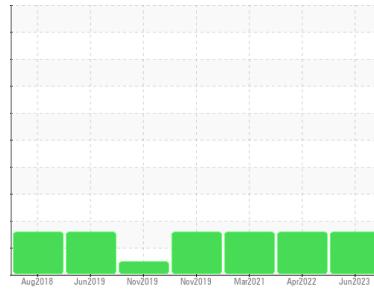
Sample Rating Trend

All component wear rates are normal.

Elemental level of silicon (Si) above normal.

The AN level is acceptable for this fluid. The condition of the oil is suitable for further service.

No corrective action is recommended at this time. Resample at the next service interval to monitor.
