# **FUEL REPORT**

# [X47254] Machine Id TADANO GR550XL-3 542059

Component Diesel Fuel Fluid NOT GIVEN (--- GAL)

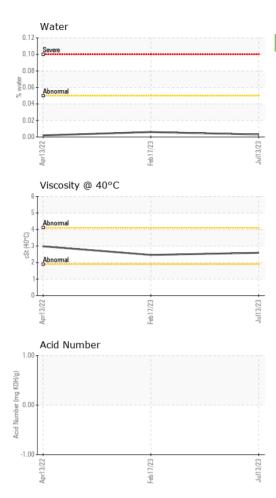
The water content is negligible. There is no indication of any contamination in the fuel.

The condition of the fuel is acceptable for the time in service.
