FP-010 Machine Id B59276 - CONVEYOR KSI INCLINE SCREW RAW PROD KSI #11 Component Gearbox

Customer Id: HORAUS Sample No.: WC0826113 Lab Number: 05904323 Test Package: IND 2

OIL ANALYSIS REPORT

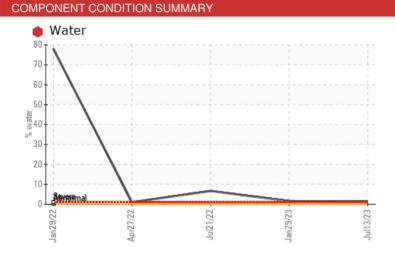
Sample Rating Trend

PROBLEMATIC TEST RESULTS								
Sample Status				SEVERE	ABNORMAL	SEVERE		
Water	%	ASTM D6304	>0.2	• 1.18		1.58		
ppm Water	ppm	ASTM D6304	>2000	🛑 11800		15800		
Debris	scalar	*Visual	NONE	A MODER	NONE	NONE		
Appearance	scalar	*Visual	NORML	🔺 MILKY	NORML	🔺 MILKY		
Emulsified Water	scalar	*Visual	>0.2	• 0.2%	NEG	0.2%

We advise that you check for the source of water entry. We advise that you follow the water drain-off procedure for this component. We recommend an early resample to monitor this condition. There is too much water present in this sample to perform a particle count.

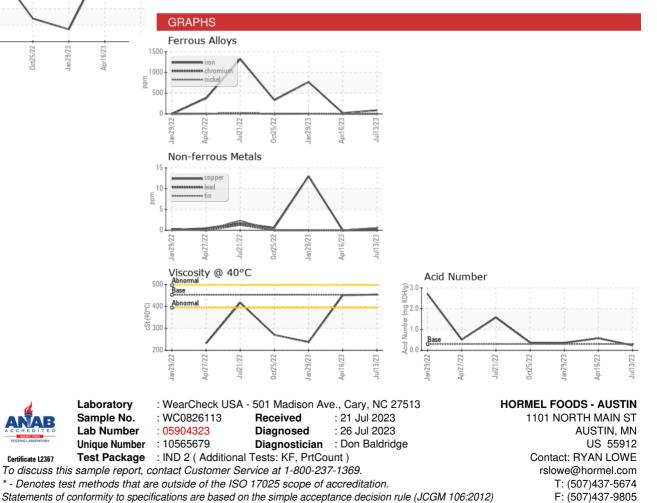
Bottom

Appearance is milky. Moderate concentration of visible dirt/debris present in the oil. There is a high concentration of water present in the oil.

We advise that you check for the source of water entry. We advise that you follow the water drain-off procedure for this component. We recommend an early resample to monitor this condition. There is too much water present in this sample to perform a particle count.
