PROBLEM SUMMARY

Area
Evp Island
 Machine Id
GOULDS B HSC Pump 0306
 Component
Pump Roller Bearing
 Fluid
MOBIL SHC 626 (1 GAL)

OIL ANALYSIS REPORT

FERROGRAPHY REPORT

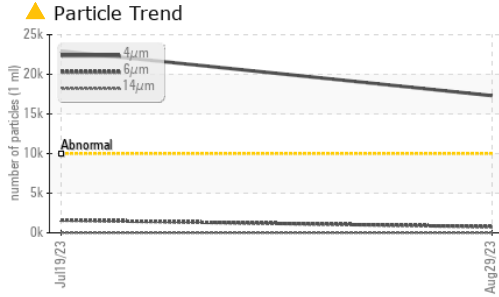
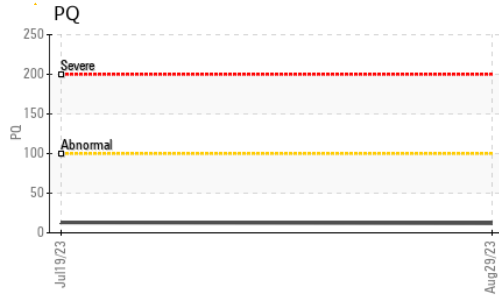
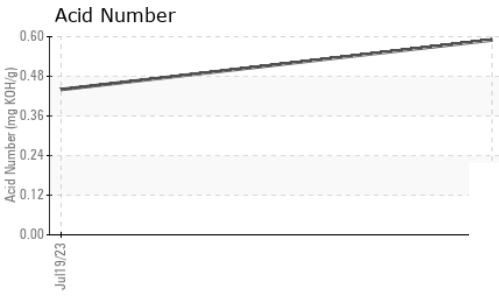
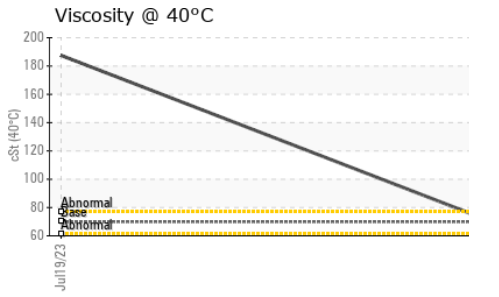
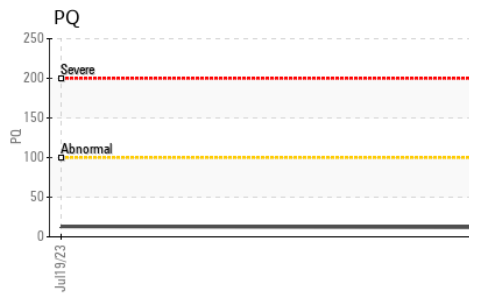
There is a light amount of silt (particulates < 14 microns in size) present in the oil.

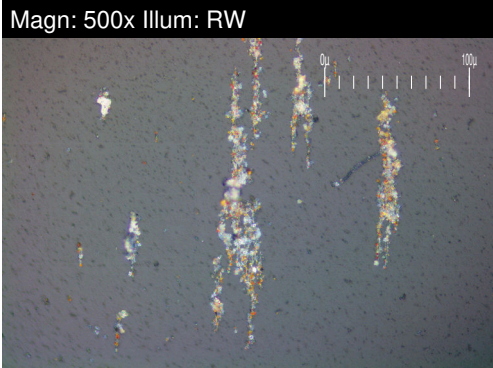
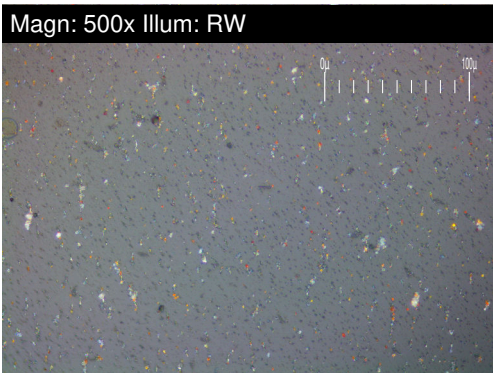
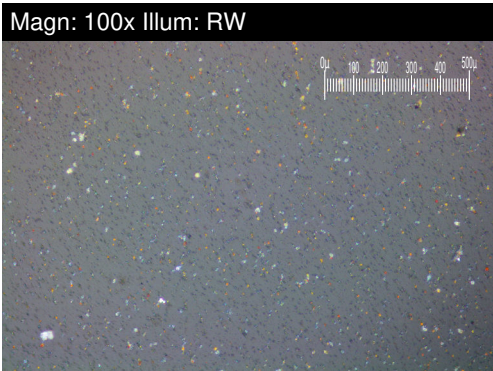
We recommend you service the filters on this component. Resample at the next service interval to monitor. Analytical Ferrography: Results suggest there is a mild source of red oxide present in this system or in refill lubricant. In the first 3 associated images from the slide, the debris is under a polarized light and any of the orange or reddish debris should be considered to most likely be a red oxide. The volume of oxide debris is not exceptionally high but it is unusual and should be dealt with at the earliest opportunity to ensure this debris does not cause any additional wear. At the moment, all other debris appears to be at a typical size and volume. If the filters for this system are not designed to handle such small debris (the average oxide particle is ~2-3 microns) consider a lubricant polish with traditional low micron filters, depth media filtration, or something similar. Consider investigating the source of contamination and correct it if possible.
